# Service Bulletin

| <b>Subject:</b><br><b>FRONT SEAT BACK TRIM SEAMS COMING APART - (LEATHER SEATS ONLY)</b> | <b>Bulletin No:</b> 09-025/13 |
| | <b>Last Issued:</b> 10/04/2013 |

2013-2014 CX-5 vehicles equipped with leather seats with VINs lower than JM3KE\*\*\*\*\*327345 (produced March 1, 2013)

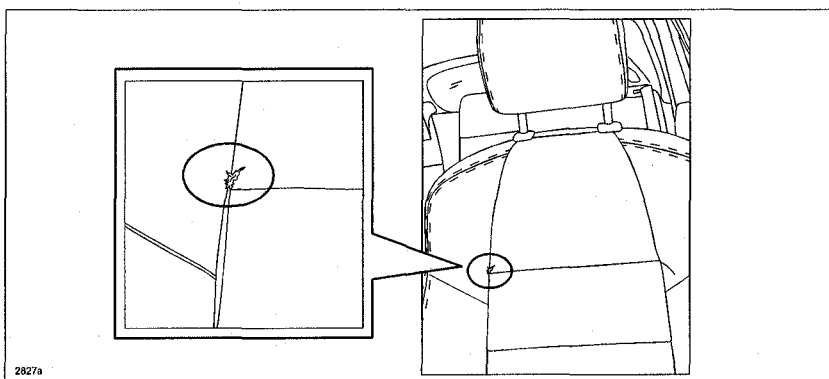
Some vehicles may exhibit a condition where the front seat back trim is coming apart at the seams. This condition is caused by insufficient sewing strength in the seams. The sewing method has been improved to eliminate this concern.

1. Verify the customer concern.
2. Replace the seat back trim with modified service parts according to the on-line instructions on MS3 or the Workshop Manual (section 09-13 FRONT SEAT BACK TRIM REMOVAL/INSTALLATION).
3. Verify the repair.
