# Service Bulletin

**FRONT SEAT BACK TRIM SEAMS COMING APART - (LEATHER SEATS ONLY)**

**Bulletin No:** 09-025/13

2013-2014 CX-5 vehicles equipped with leather seats with VINs lower than JM3KE\*\*\*\*\*327345 (produced March 1, 2013)

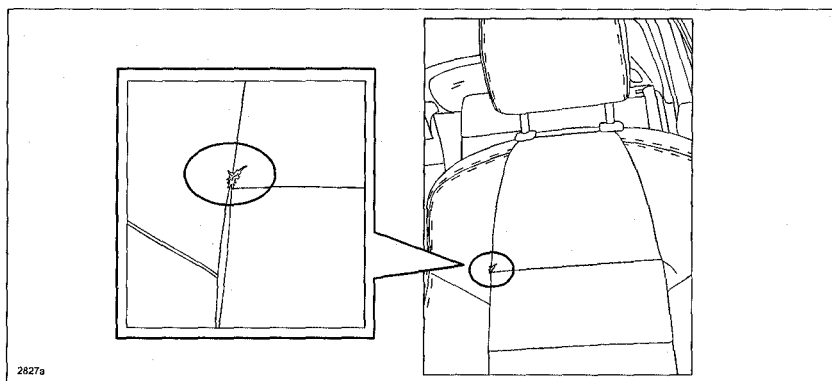
Some vehicles may exhibit a condition where the front seat back trim is coming apart at the seams. This condition is caused by insufficient sewing strength in the seams. The sewing method has been improved to eliminate this concern.

1. Verify the customer concern.
2. Replace the seat back trim with modified service parts according to the on-line instructions on MS3 or the Workshop Manual (section 09-13 FRONT SEAT BACK TRIM REMOVAL/INSTALLATION).
3. Verify the repair.
