Subject: NOISE COMING FROM UNDER THE DRIVER SEAT	Bulletin No: 09-026/13
	Last Issued: 10/09/2013

2013 CX-5 vehicles without power seats with VINs lower than JM3KE*****144861 (produced Aug. 24, 2012)

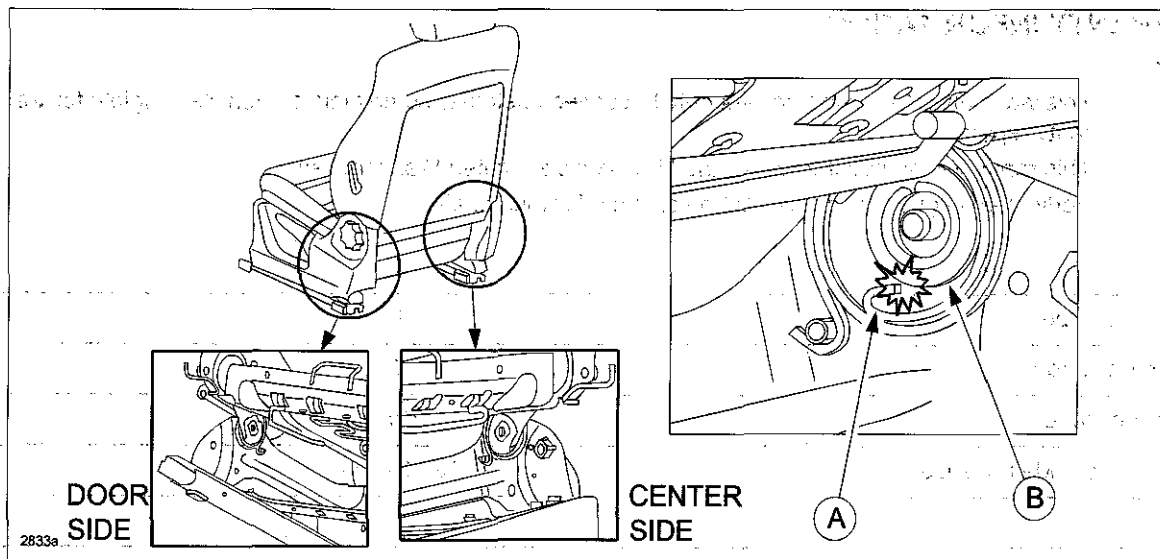
Some vehicles may exhibit a noise from under the driver seat while driving the vehicle. The noise may be caused by vibration when the bent-up end of the balance spring (A) interferes with the slider bushing (B).

To eliminate the noise, the clearance between the balance spring and the slider bushing has been increased. Customers having this concern should have their vehicle repaired using the following repair procedure.
