Service Bulletin

Subject: WHITE STAINS FROM OUTER DOOR MIRROR RUNNING DOWN DOOR PANEL	Bulletin No: 09-028/13
	Last Issued: 10/31/2013

2013-2014 CX-5 vehicles with VINs **between JM3KE*****138997 ~ 398338** and produced from July 24, 2012, to October 1, 2013

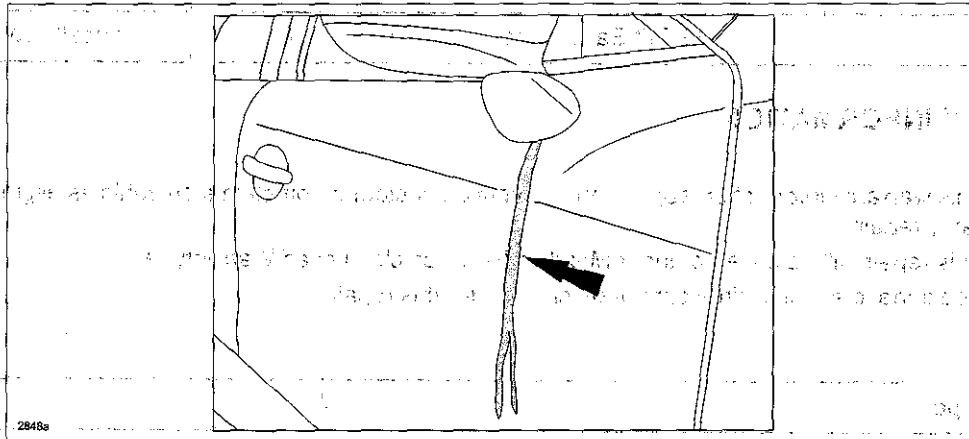
Some vehicles may exhibit a white stain running down the front door(s), which originates from under the outer door mirror. This is caused when water (containing white corrosion) is generated inside the door mirror base, then drains down the door panel causing a poor appearance concern.

The door mirror base was originally designed to drain water to the outside of the door. The shape of the door mirror base gasket has been modified to now drain water to the inside of the door. Replacing the gasket should eliminate this concern.
