Service Bulletin

Subject: REAR DOOR WEATHERSTRIP OUT OF POSITION	Bulletin No: 09-029/13
	Last Issued: 11/05/2013

2014 Mazda6

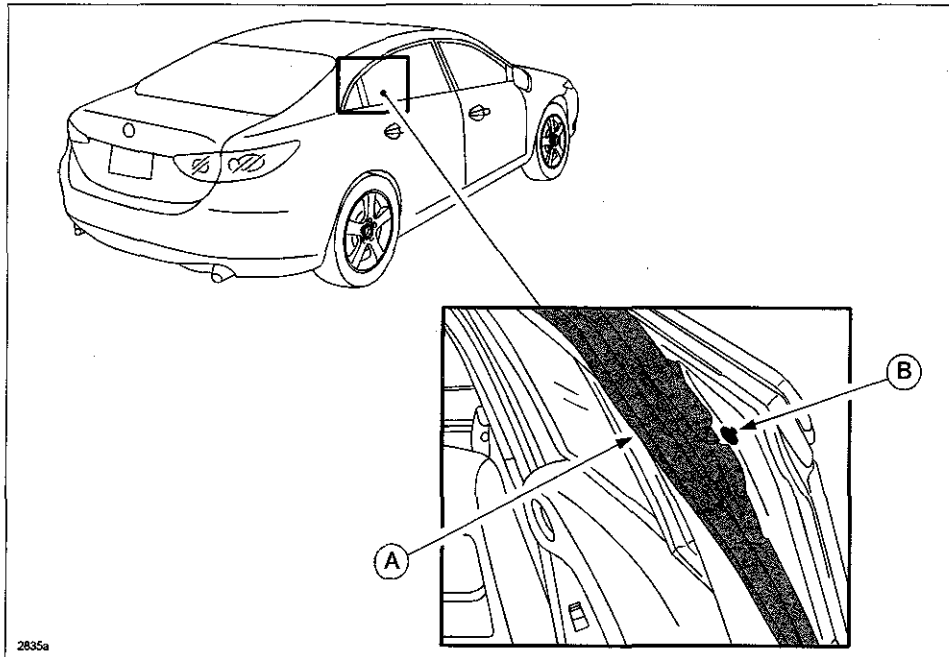
Some customers may have a concern with the top edge of the rear door weatherstrip (A) detached from fastener (B).

Customers having this concern should have their vehicle repaired using the following repair procedure.
