Subject: LIFTGATE LATCH HANDLE GASKET PEELING OR HANGING LOOSE	Bulletin No: 09-033/13
	Last Issued: 11/19/2013

2010-2011 Tribute

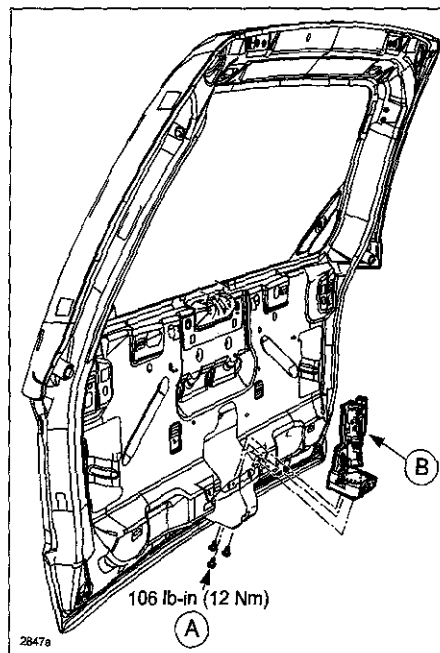
Some vehicles may exhibit a condition with the liftgate latch handle gasket peeling or hanging loose. Customers having this concern should have their vehicle repaired using the following repair procedure.

1. Verify customer concern.
2. Remove the liftgate trim panel. Refer to MS3 online or Workshop Manual (section 09-17 LIFTGATE TRIM PANEL REMOVAL/INSTALLATION).
3. Disconnect the liftgate latch electrical connectors.
4. Remove and discard the 3 liftgate latch bolts (A).
Tightening Torque: 106 in-lb (12 Nm)
5. Remove the liftgate latch assembly (B).
