<b>Subject:</b>  HOOD VIBRATION WHILE DRIVING AT HIGHWAY SPEED	<b>Bulletin No:</b> 09-036/13
	<b>Last Issued:</b> 12/10/2013

2013-2014 CX-5 vehicles with VINs lower than JM3KE\*\*\*\*\*387092 (produced before September 1, 2013)

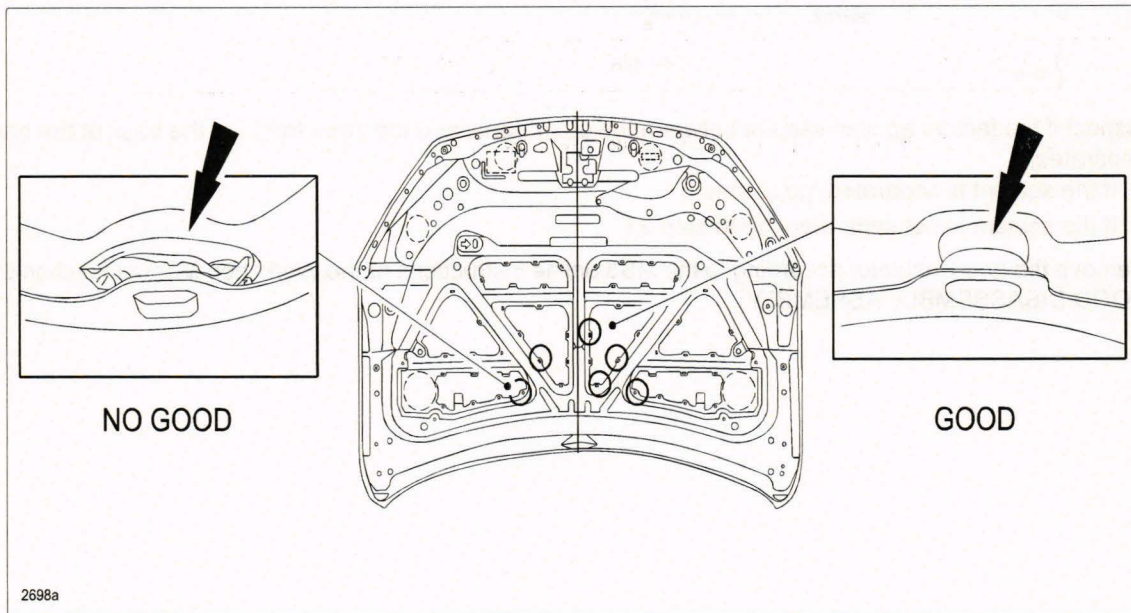
The amount of sealant used to fill in the space between the inner frame and outer panel at the bottom area of the hood is insufficient. If the sealant detaches (as shown below on the left), it may cause the hood to vibrate.

The amount of sealant has been increased during vehicle production and the preload force of the cowl grill seal has been increased to eliminate the concern.

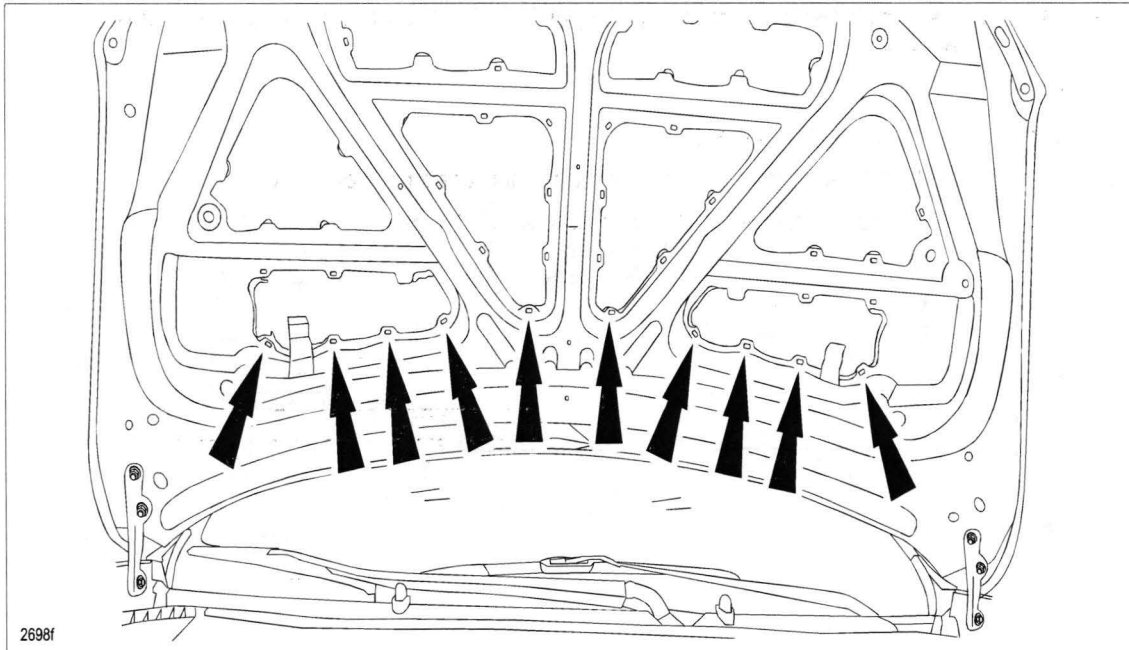
6. Confirm the ten (10) original sealant spots at the bottom area of the hood.

- Additional dampening material will be applied **between** these ten (10) original sealant spots.
- It is not necessary to apply dampening material to other areas of the hood. Even if the original sealant has become detached, it will have no influence on the hood vibration concern.
