UNABLE TO ADJUST DRIVER SEAT UP OR DOWN - (MANUAL SEAT ONLY)

Bulletin No: 09-037/13

2010-2012 CX-7 vehicles equipped with manual seats

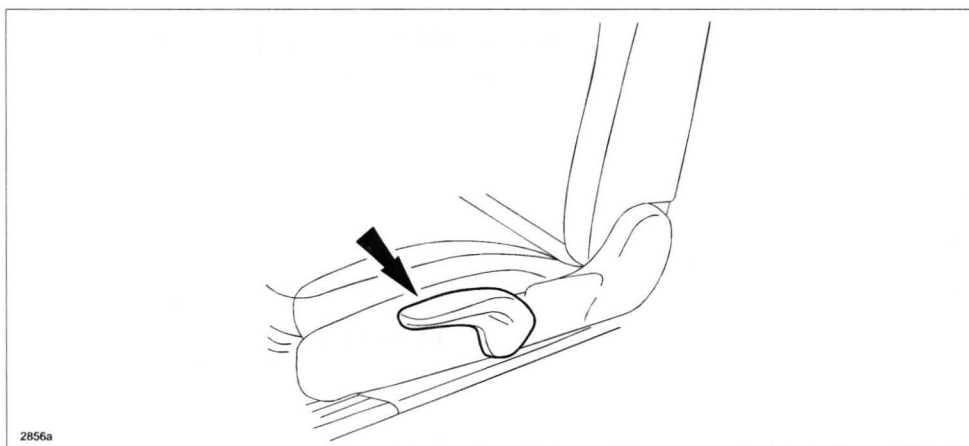
On some vehicles, it may be difficult to adjust the driver seat up or down using the manual seat lift lever.

This may be caused by a broken front seat side cover that interferes with the operation of the seat lifter mechanism. The cover may have been previously broken by an outside impact.

1. Verify the customer concern.
2. Replace the front seat side cover with a modified one according to the instructions on MS3 online or the Workshop Manual (section 09-13 FRONT SEAT SIDE COVER REMOVAL/INSTALLATION).
3. Verify the repair.
