09-038/13 - 2014 MAZDA3 (WITH MAZDA CONNECT) - VARIOUS AUDIO SYSTEM CONCERNS WITH TUNER AND AMP UNIT (TAU)

<b>Subject:</b> VARIOUS AUDIO SYSTEM CONCERNS WITH TUNER AND AMP UNIT (TAU)	<b>Bulletin No:</b> 09-038/13
	<b>Last Issued:</b> 12/19/2013

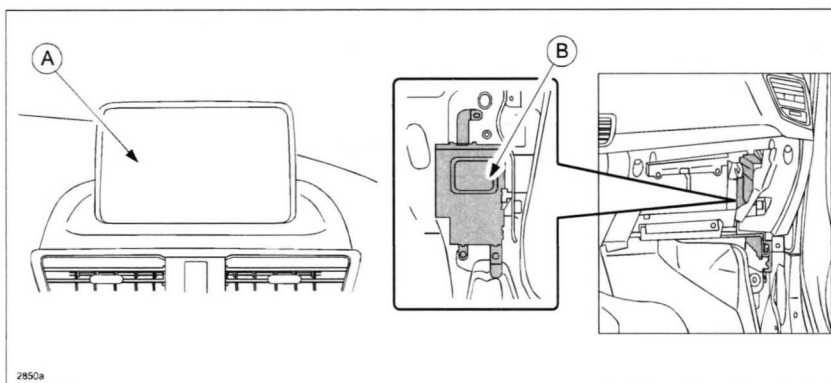
Some vehicle may experience any one of the symptoms below that can be resolved with a modified TAU.

- AM/FM/XM cannot be selected as they are grayed out
- Radio station returns to 87.9MHz on its own
- Audio sound setting resets on its own
- TAU version is displayed as "not available"

1. Verify customer concern.
2. On vehicle with a touchscreen (A), remove the TAU (B) and replace with a modified one. Refer to MS3 online instructions or Workshop manual (section 09-20 TUNER AND AMP UNIT (TAU) REMOVAL/INSTALLATION).
