<b>HYUNDAI</b>   NEW THINKING. NEW POSSIBILITIES.  Technical Service Bulletin	GROUP <b>Campaign</b>	NUMBER <b>13-01-046</b>
	DATE <b>November 2013</b>	MODEL(S) <b>2014 Tucson (LM), Santa Fe (NC) and Santa Fe Sport (AN)</b>

**SUBJECT: AUDIO SYSTEM SOFTWARE UPDATE (SERVICE CAMPAIGN TR2)**

**DESCRIPTION:** This bulletin describes the procedure of updating the operating system software for 2014 Model Year Tucson, Santa Fe and Santa Fe Sport audio systems.

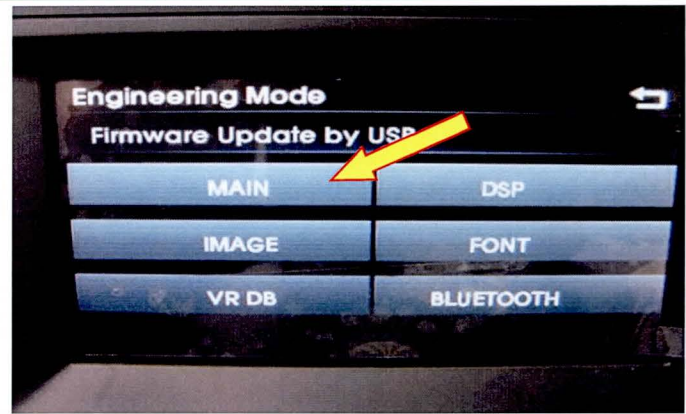
After the MAIN software update is completed, there may be a graphical defect. Continue to procedure (17) to repair the graphical concern.

16. Touch 'MAIN' on the display screen to start the update of the main operating software.

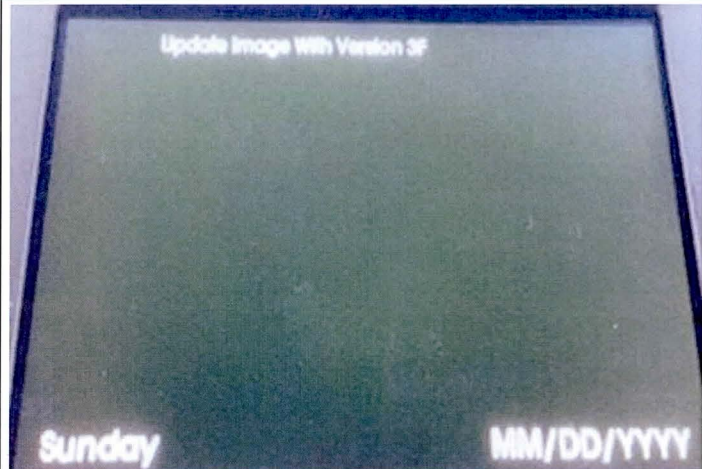
17. Sometimes after the "MAIN" software update is completed the final image is not updated like the sample image to the right "Update Image With Version 3F", to repair this concern go back to procedure (12) above and update the system using the automatic procedure described.

When complete, continue to procedure (18) below to confirm the version number.
