**HYUNDAI** | NEW THINKING.  
NEW POSSIBILITIES.

**Technical Service Bulletin**

GROUP <b>BODY</b>	NUMBER <b>13-BD-004</b>
DATE <b>OCTOBER 2013</b>	MODEL(S) <b>TUCSON (LM)</b>

SUBJECT: **OUTSIDE REAR VIEW MIRROR REPAIR**

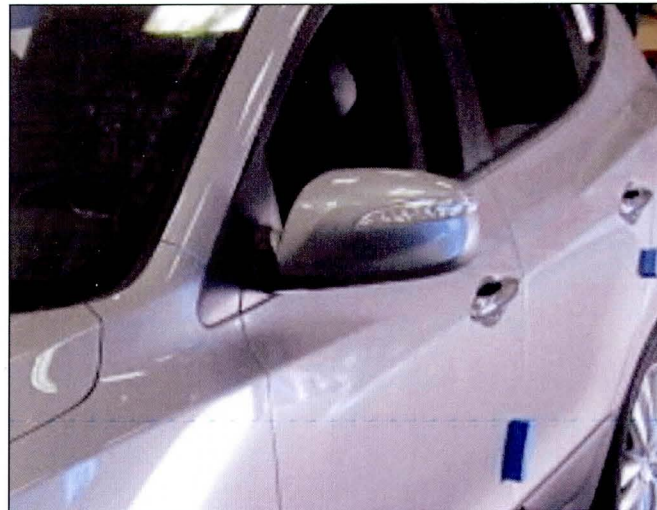
**Description:** Some Tucson (LM) may experience vibration and/or sound due to the left or right outside mirrors being loose. This bulletin describes the procedure to add Loctite to the outside mirror base mounting screw.
