S-SB-0041-13

Taillight Lens Cracking

YEAR(S)	MODEL(S)	ADDITIONAL INFORMATION		
2013 – 2014	FR-S

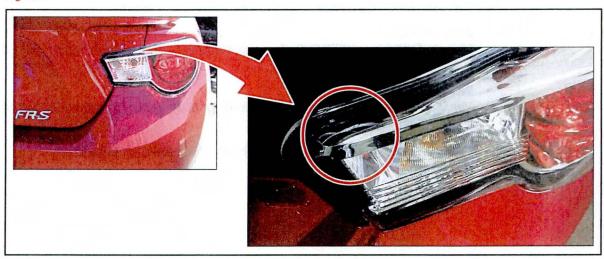
Figure 1.

The rear combination lights on some 2013 – 2014 model year FR-S vehicles may exhibit cracking from the upper surface of the lens. This can result from the trunk lid contacting the rear combination light housing if excessive force is applied to the trunk lid when closing. Follow the Repair Procedure in this bulletin to address this condition.

1. Confirm the upper surface of the lens in the rear combination light is cracked.

2. Replace the Luggage Compartment Door Weatherstrip.

3. Replace the Luggage Compartment Door Cushions.

4. Replace combination light by removing the components from the combination light housing.
