Taillight Lens Cracking

YEAR(S)	MODEL(S)	ADDITIONAL INFORMATION	
2013 – 2014	FR-S

S-SB-0041-13

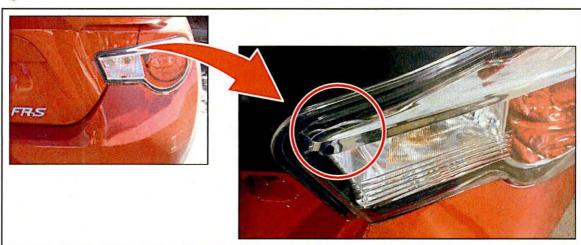
Figure 1.

The rear combination lights on some 2013 – 2014 model year FR-S vehicles may exhibit cracking from the upper surface of the lens. This can result from the trunk lid contacting the rear combination light housing if excessive force is applied to the trunk lid when closing. Follow the procedure in this bulletin to address this condition.

1. Confirm the upper surface of the lens in the rear combination light is cracked.
