# Rubbing or Grinding Noise From Rear on Turns

Service  
Category Brake

Section Brake (rear)

YEAR(S)	MODEL(S)	ADDITIONAL INFORMATION
2007 – 2012	Tundra

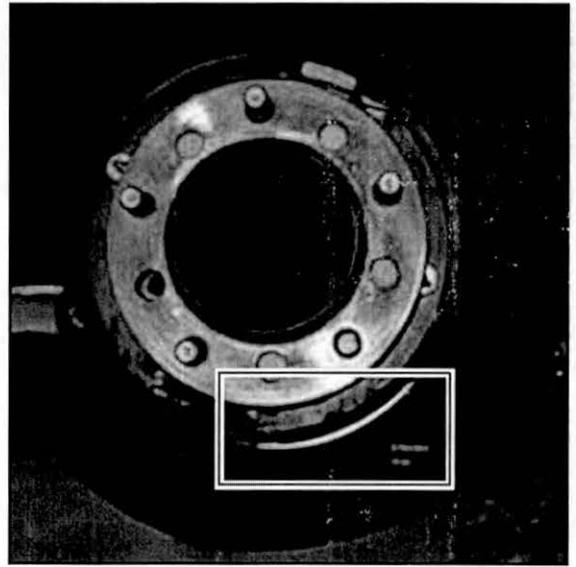
Some 2007 – 2012 model year Tundra vehicles may exhibit a rubbing or grinding noise from the rear when making left or right turns. New parking brake plate sub-assemblies have been developed to address this condition.

1. Test drive the vehicle and confirm the condition by making left and right hand turns.
2. Once the condition has been confirmed, place the vehicle on the lift, remove the rear wheels and rear rotors and check for any irregular contact on the brake plate from the rotors.

Figure 1. Example of Irregular Contact on Brake Plate

3. If there appears to be irregular contact from the rotor to the brake plate, replace all parts specified in the Special Service Part Bearing Kit (including the parking brake backing plate).
