Steering Column "Pop" Noise

Service
Category Steering

YEAR(S)	MODEL(S)	ADDITIONAL INFORMATION
2009 – 2013	Venza

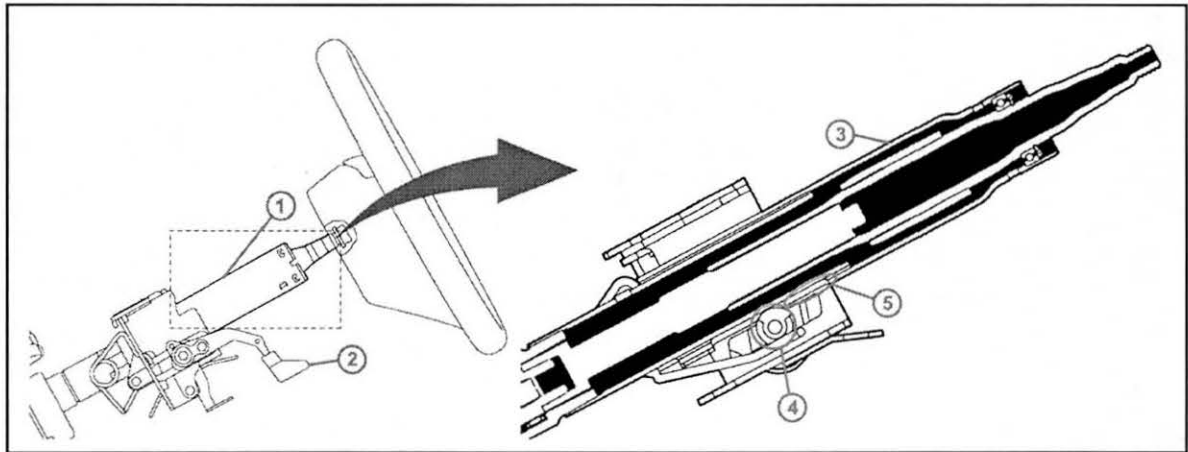
Figure 1.

Some 2009 – 2013 model year Venza vehicles may exhibit a "pop" noise from the steering column when turning the steering wheel sharply during low speed maneuvers. Perform the repair procedure outlined in this bulletin to address this condition.

With the vehicle in Park and engine running, release the column tilt/telescopic lever and rotate the steering wheel from right lock to left lock several times (refer to Figure 1).

With the tilt/telescopic lever released, did the steering "pop" noise go away?
