# Ticking Noise from Rear Package Tray

Service Category Vehicle Exterior

Section Body Structure

YEAR(S)	MODEL(S)	ADDITIONAL INFORMATION
2013	FR-S	WMI(s): JF1

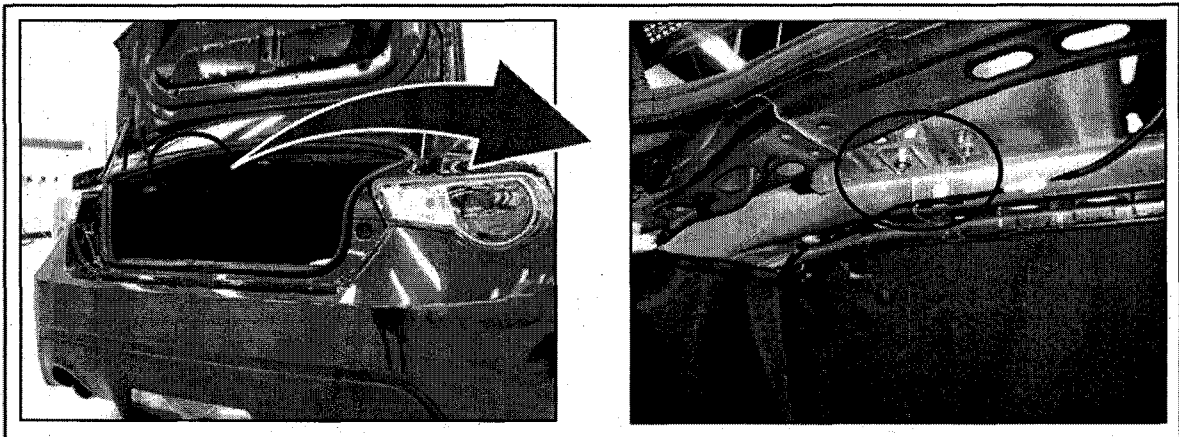
Figure 2. Driver Side

1. Test drive the vehicle to confirm that a noise is coming from the rear package tray area circled in Figures 2 and 3.

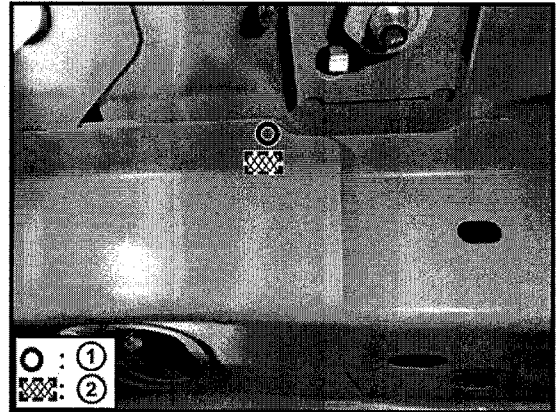
Figure 4. Driver Side

- A. The noise source is located immediately adjacent to the vertical surface of the package tray as shown below. The adjustment area is located between the spot weld and vertical section.

1	Spot Weld
2	Adjustment Area A

2. Adjust the gap between the lower and middle sheet metal panels as described below.

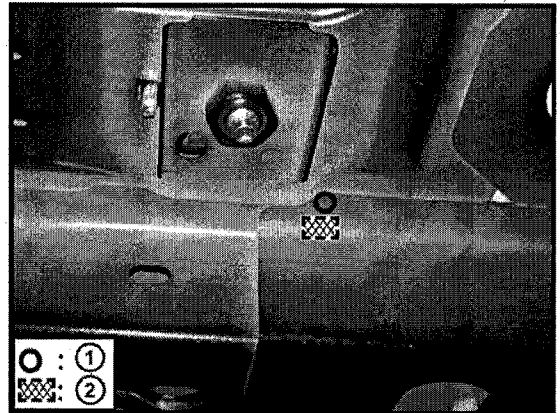
Figure 5. Passenger Side

1	Spot Weld
2	Adjustment Area A

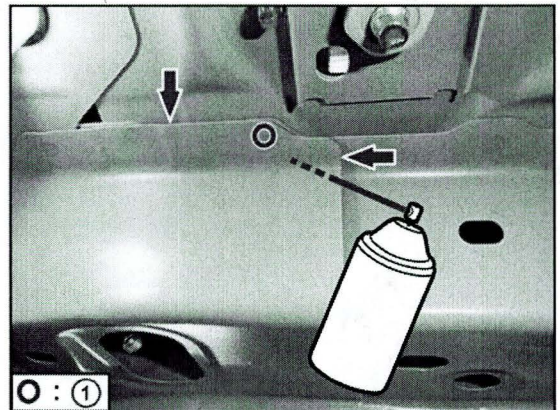
Figure 7.

1 Spot Weld

- A. Insert the spray tube between the sheet metal panels as shown.
- B. Wipe away excess lubricant.

Do NOT use silicone-based lubricant because it can have adverse effects on electronic components.

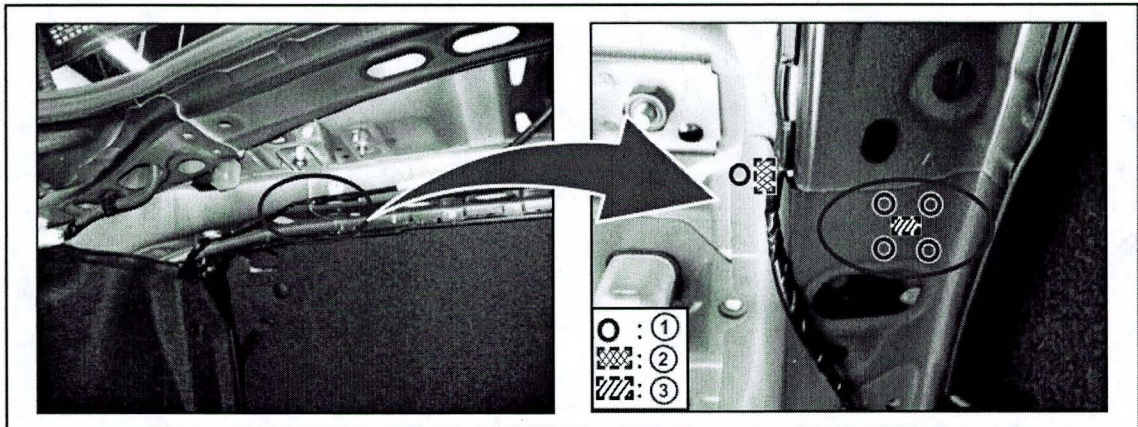
Figure 8. Driver Side View From Under – Looking Up

1. Confirm a noise is coming from the spot welded area shown in Figures 8 and 9. Noise source area is under the vertical section in Repair Procedure 1, shown in Figure 4.
  - A. Apply finger pressure to Adjustment Area B which is located between the 4 indicated spot welds to confirm that the noise is present.

1	Spot Weld
2	Adjustment Area A

3	Adjustment Area B
---	-------------------

2. Adjust the gap between the lower and middle sheet metal panels.
  - A. Using the peen of the hammer, gently tap on Adjustment Area B (shown in Figures 8 and 9) by snapping the wrist with a 60 mm (approximately 2.36 in.) stroke.
  - B. Confirm the gap between the sheet metal sections has been reduced.
3. Test drive the vehicle and confirm that the noise is no longer present from the areas identified in Repair Procedure 1 or 2.

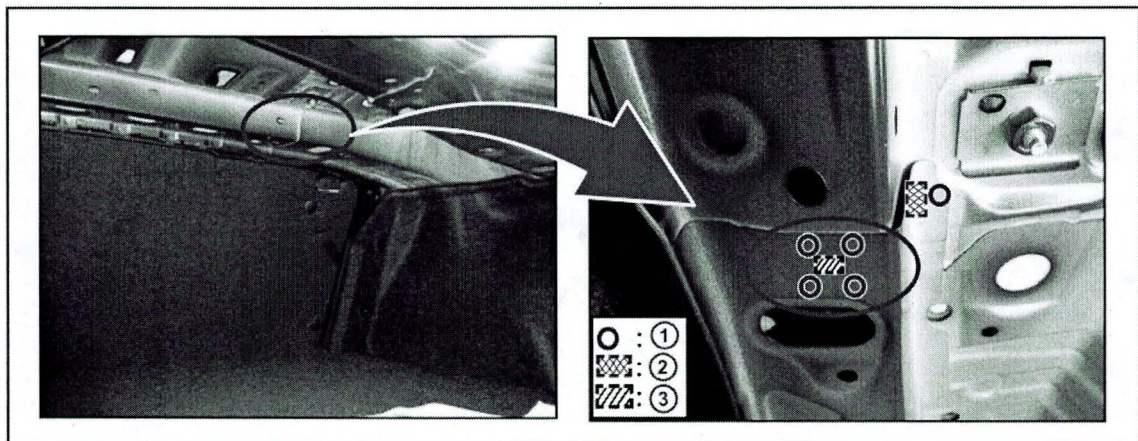
Figure 9. Passenger Side View From Under – Looking Up

1	Spot Weld
2	Adjustment Area A

3	Adjustment Area B
---	-------------------

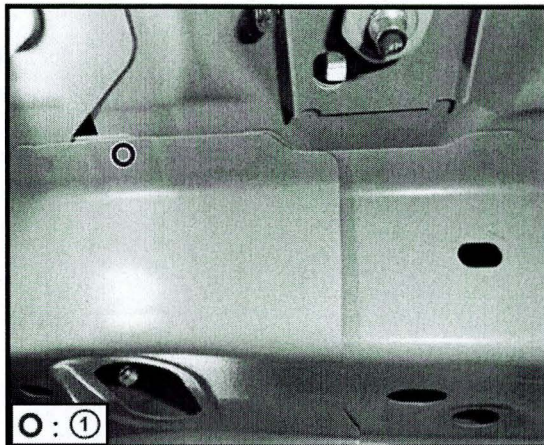
Figure 10. Driver Side View

1. Confirm that the noise is coming from the rear package tray area as indicated below.

1	Spot Weld
---	-----------

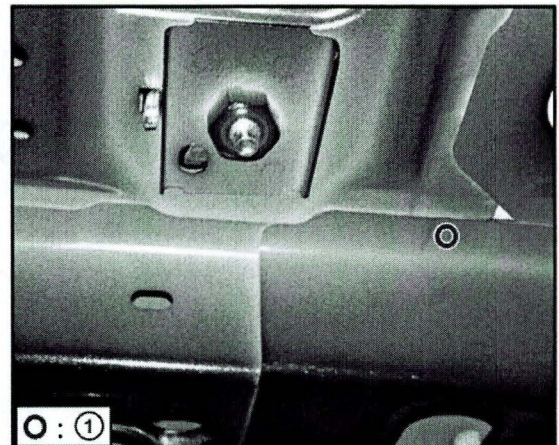
Figure 11. Passenger Side View

1	Spot Weld
---	-----------

- B. From the inside of the vehicle, use a 5 mm Hex wrench (or equivalent) and the side face of a hammer to tap on the adjustment section as shown in Figure 11, 12 and in the video.  
[Adjustment Video](#)

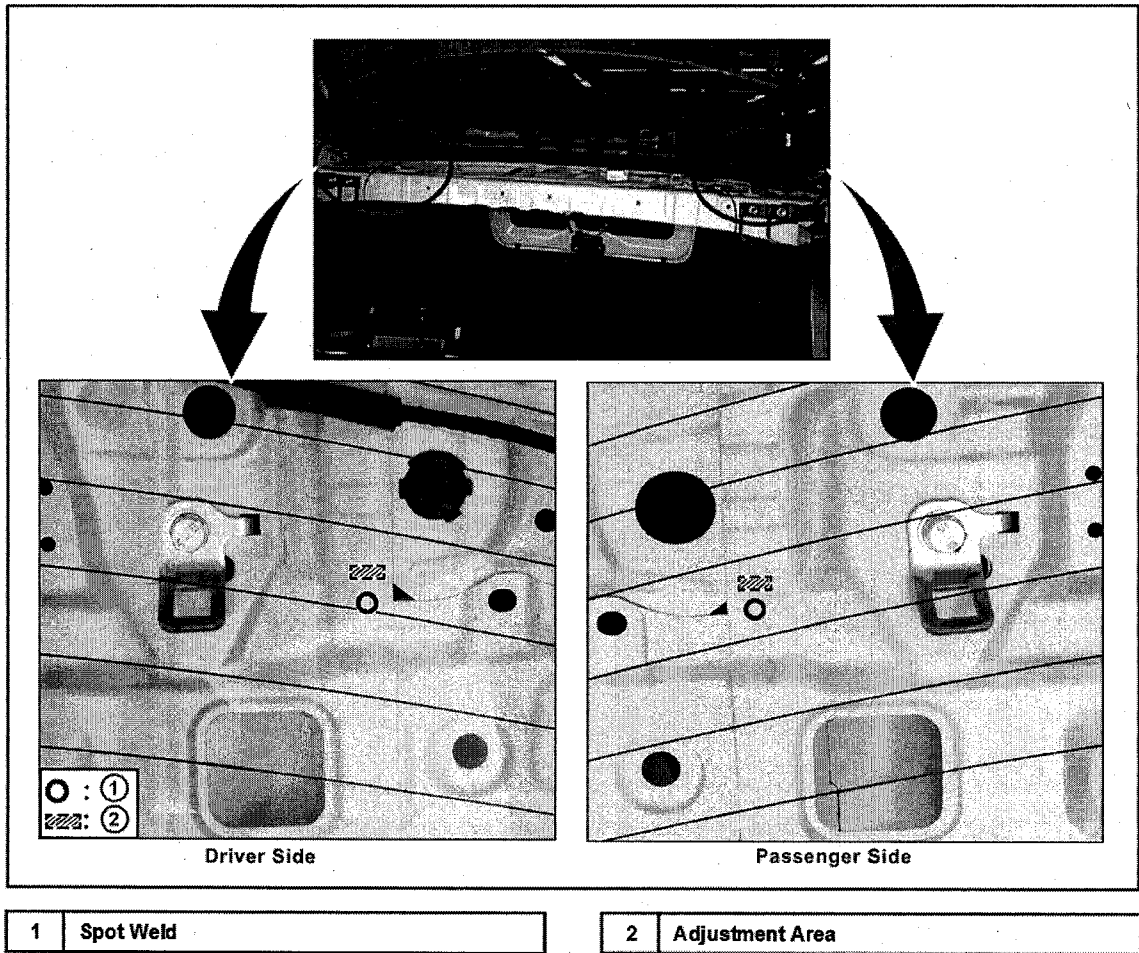
Figure 12. View From Inside of Vehicle Without Package Tray

A. The area of concern is serviceable from the top of the rear package tray sheet metal. See Figure 12 for adjustment area.

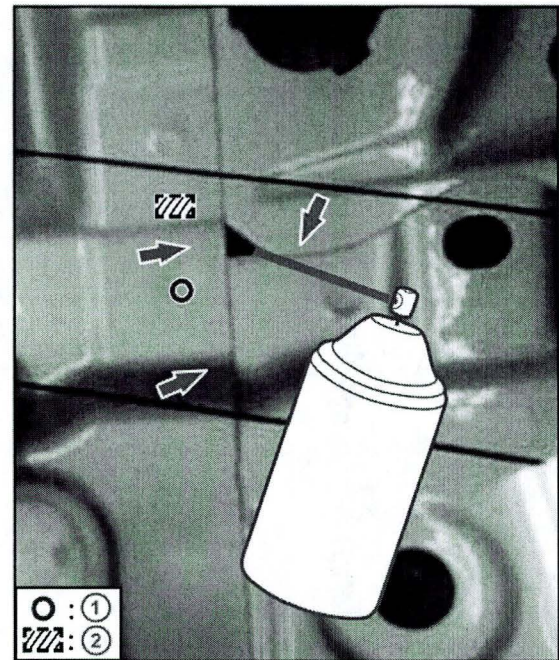
Figure 15.

1	Spot Weld
2	Adjustment Area

- C. Confirm the gap between the sheet metal panels has been reduced.
4. Use Castle® Endura™ Heavy Duty Penetrating Grease between the sheet metal panels. Wipe away excess lubricant.

**NOTICE**  
 Do NOT use silicone-based lubricant because it can have adverse effects on electronic components.
