Service

Category Vehicle Exterior

Window/Glass

Introduction

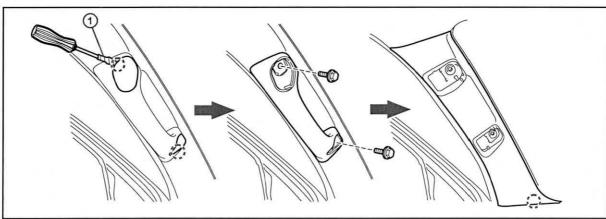
Figure 2.

- 2. Remove the front pillar garnish.
 - A. Using a screwdriver, detach the 2 claws and remove the 2 assist grip plugs.

- B. Remove the 2 bolts and assist grip.
- C. Detach the claw and remove the front pillar garnish.
