ECU Software Update: Charging System Improvement

Service Category Engine/Hybrid System

Section Hybrid/Battery Control System

YEAR(S)	MODEL(S)	ADDITIONAL INFORMATION
2012 – 2013	RAV4 EV

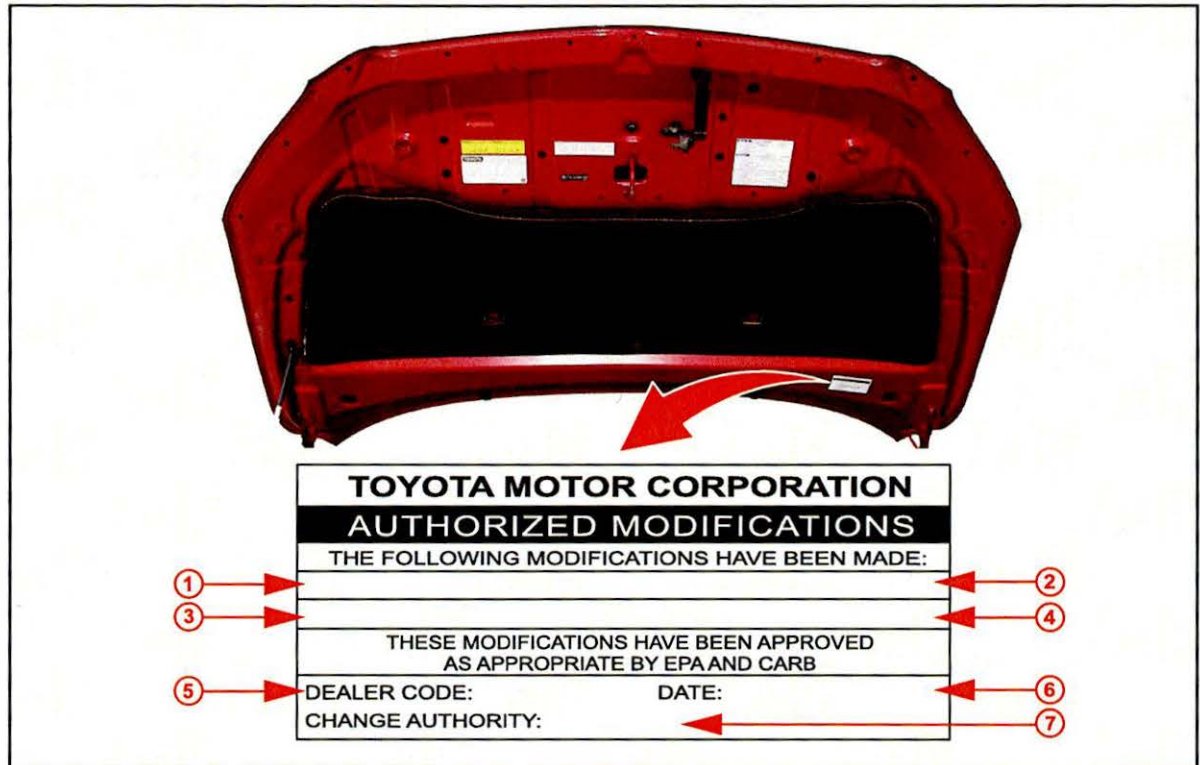
Figure 1. Location of Authorized Modifications Label on 2012 – 2013 RAV4 EV

1. Check for the Authorized Modifications Label affixed to the vehicle in the location shown in Figure 1. Confirm if the ECU calibrations have been updated. If the calibration IDs listed are NOT the latest ECU calibrations — go to step 2.

1	Replacement Power Management Control ECU Part Number (i.e., 89690-42015)
2	Replacement EV Gateway Control ECU Part Number (i.e., 89881-0R011)
3	New Calibration ID of Power Management Control ECU (i.e., 896B34201500)
4	New Calibration ID of EV Gateway Control ECU (i.e., 1.3.79)

5	Dealer Code
6	Date Completed
7	This SB Number

- Install the Authorized Modifications Label.
 - Using a permanent marker, enter the following information on the label:
 - ECU part number(s) [Refer to the **Parts Information** section for the **NEW PART NUMBER**]
 - Calibration ID(s) [Refer to the **Calibration Information** section for the **NEW CALIBRATION ID**]
 - Dealer Code
 - Repair Date
 - Change Authority [**This SB number**]
 - Affix the Authorized Modifications Label to the vehicle at the location shown in Figure 1. The Authorized Modifications Label is available through the MDC, P/N 00451-00001-LBL.
- Test drive the vehicle to confirm proper vehicle operation.

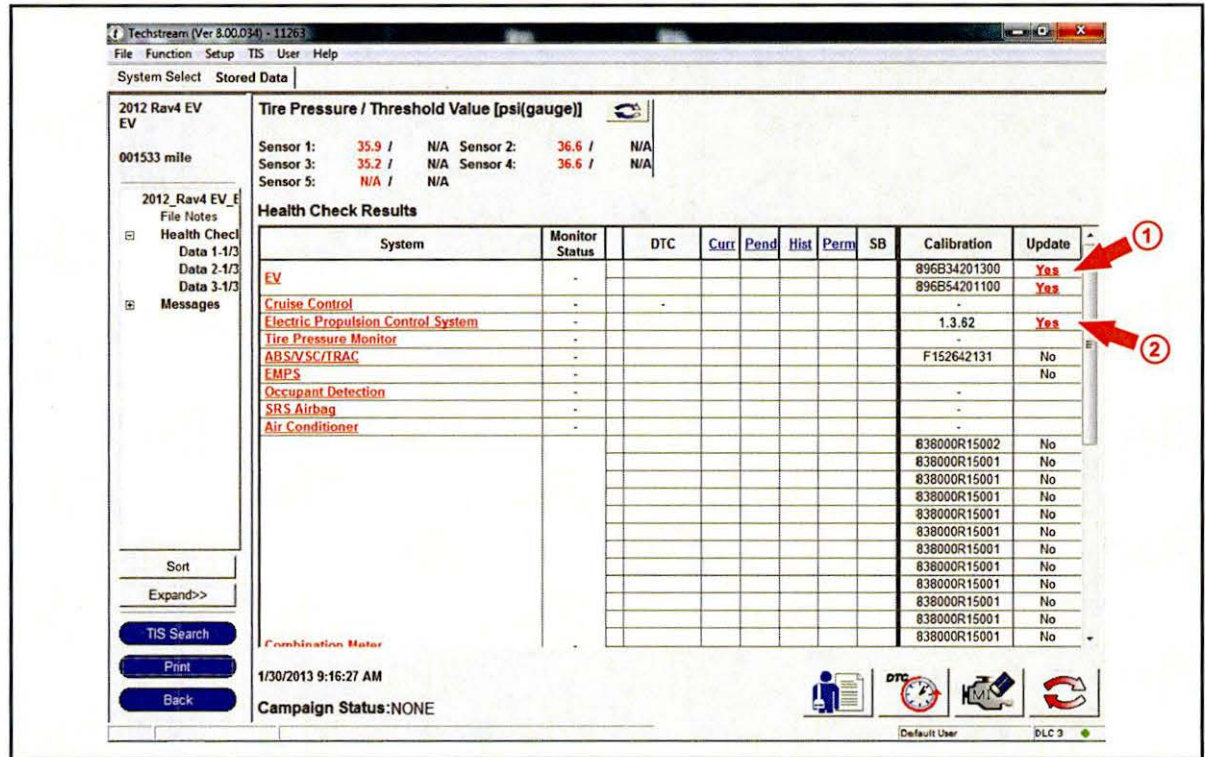
Figure 2.

NOTICE
 The Power Management Control ECU must be updated first, then the EV Gateway Control ECU (see Figure 2).

1 Reprogram Power Management Control ECU 1st

2 Reprogram EV Gateway Control ECU 2nd
