Flex Fuel Extended Crank due to Alcohol Density Calculation

Service Category Engine/Hybrid System

Section Engine Control

YEAR(S)	MODEL(S)	ADDITIONAL INFORMATION
2012 – 2013	Sequoia	
2012 – 2013	Tundra

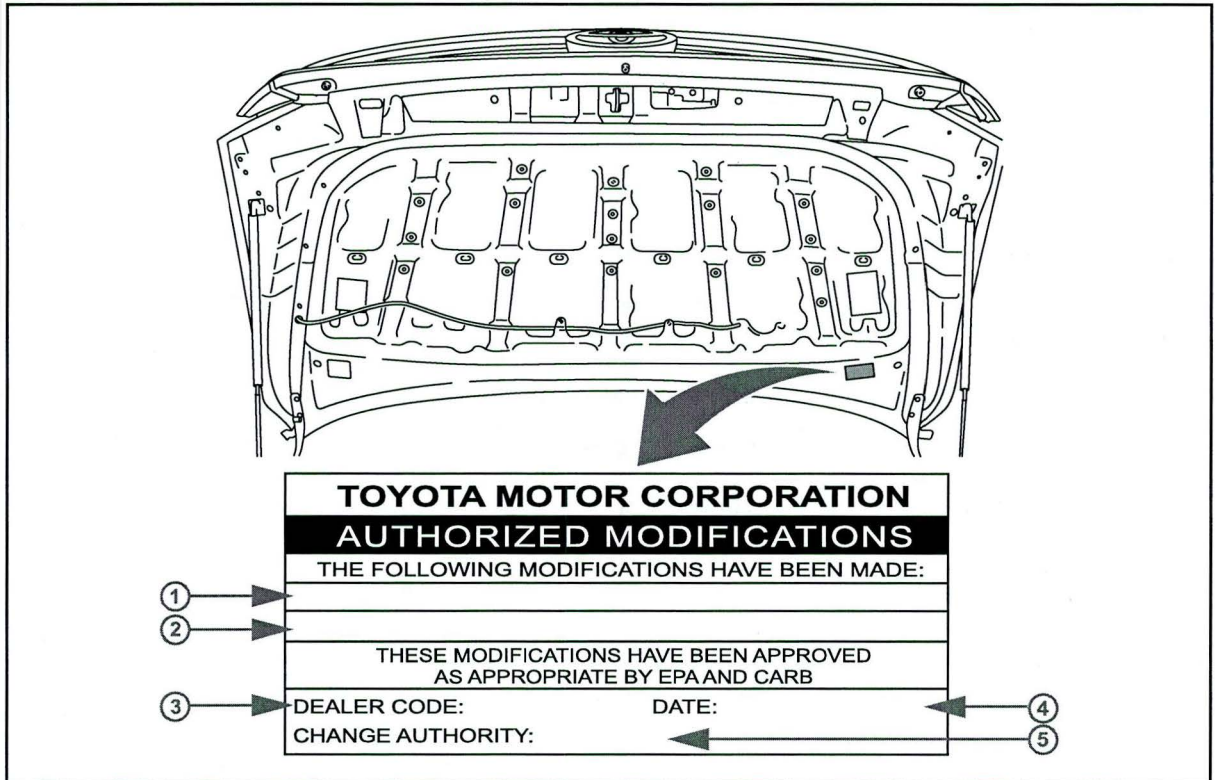
Figure 1. Location of Authorized Modifications Label on 2012 – 2013 Sequoia and Tundra

4. Check for the Authorized Modifications Label affixed to the vehicle in the location shown in Figure 1. Confirm if the ECM (PCM) calibration has been updated. If the calibration ID listed is NOT the latest ECM (PCM) calibration — go to step 5.

6. Install the Authorized Modifications Label.
 - A. Using a permanent marker, enter the following information on the label:
 - ECM part number [*Refer to the **Parts Information** section for the **NEW PART NUMBER***]

- Calibration ID(s) [*Refer to the **Calibration Information** section for the **NEW CALIBRATION ID***]
 - Dealer Code
 - Repair Date
 - Change Authority [***This SB number***]

- B. Affix the Authorized Modifications Label to the vehicle at the location shown in Figure 1. The Authorized Modifications Label is available through the MDC, P/N 00451-00001-LBL.
