T-SB-0088-13

July 26, 2013

MIL "ON" DTC P0A80 or P0A7F due to Dust or Debris in HV Battery Cooling Fan

YEAR(S)	MODEL(S)	ADDITIONAL INFORMATION
2012	Camry HV

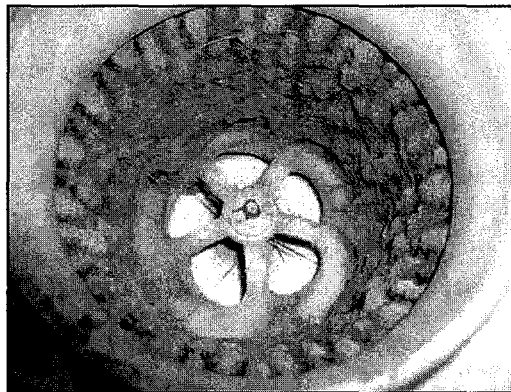
Figure 1.

Some 2012 model year Camry HV vehicles may exhibit a MIL "ON" condition with Diagnostic Trouble Code (DTC) P0A80 or P0A7F stored due to dust or debris build-up in the HV Battery Cooling Fan. Use the following repair procedure to address this condition.

Is the HV Battery Cooling Fan clogged with dust or debris build-up? Refer to Figure 1 for an example of a clogged cooling fan.

2. Clean dust and debris build-up from the HV Battery Cooling Fan with compressed air or vacuum.

Do NOT allow the cooling fan to spin freely during cleaning. This may damage the cooling fan motor.

3. Replace the HV Battery Assembly.
