Radio Screen Brightness Difference Between Modes

Service Category Audio/Visual/Telematics

Section Navigation/Multi Info Display

YEAR(S)	MODEL(S)	ADDITIONAL INFORMATION
2013	RAV4

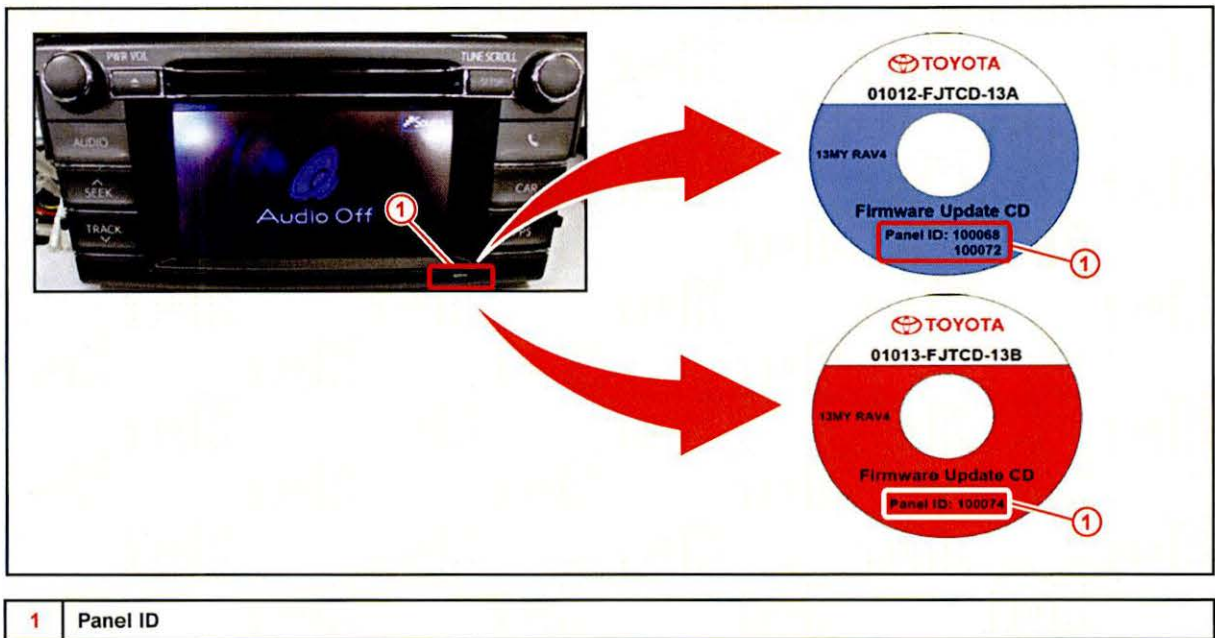
Figure 1.

SPECIAL SERVICE TOOLS (SST)	PART NUMBER	RADIO ASSEMBLY PART NUMBER	PANEL ID	DISC COLOR
CD Firmware Update - Fujitsu Ten	01012-FJTCD-13A	86140-42020	100068	Blue
		86140-0R020	100072	
	01013-FJTCD-13B	86140-0R040	100074	Red
