MIL "ON" DTC P014C, P014D, P014E, or P014F

Service Category Engine/Hybrid System

Section Engine Control

YEAR(S)	MODEL(S)	ADDITIONAL INFORMATION
2010 – 2012	IS250	Transmission(s): 6AT
2010 – 2012	IS250C	Transmission(s): 6AT

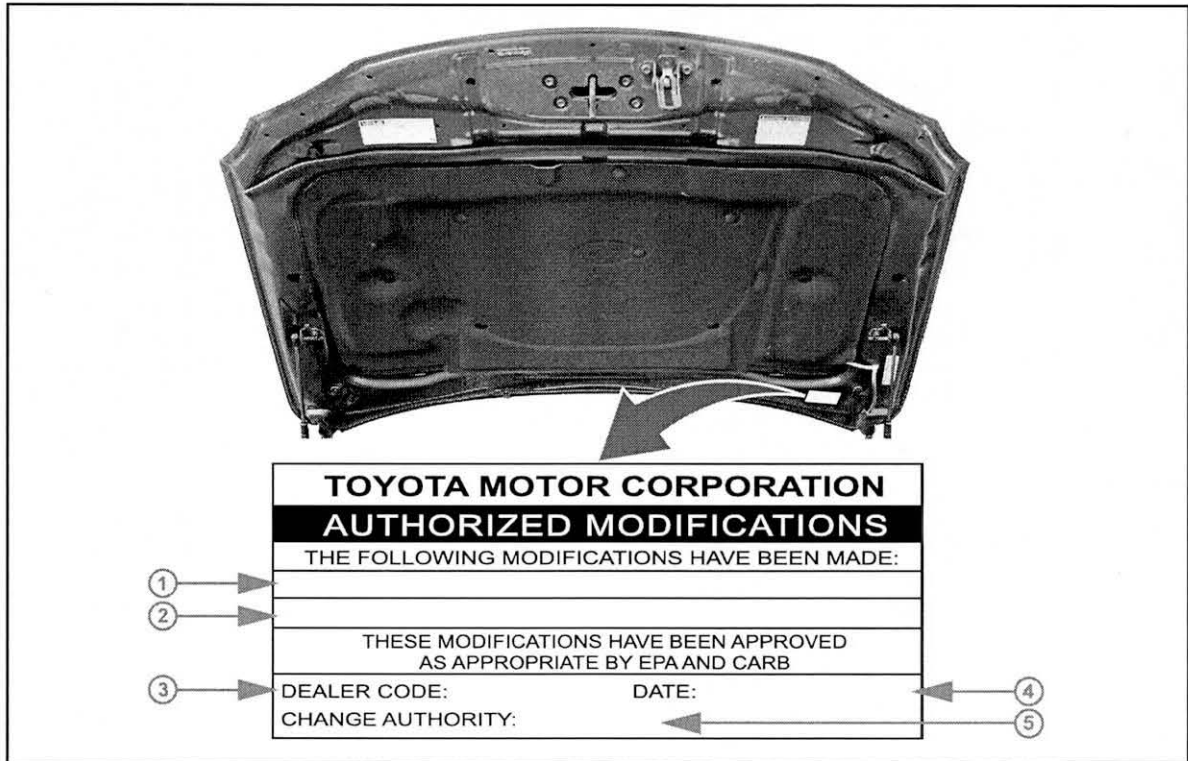
Figure 1. Location of Authorized Modifications Label on 2010 – 2012 IS 250/250C

2. Check for the Authorized Modifications Label affixed to the vehicle in the location shown in Figure 1. Confirm if the ECM (PCM) calibration has been updated. If the calibration ID listed is NOT the latest ECM (PCM) calibration — go to step 3.

4. Install the Authorized Modifications Label.
 - A. Using a permanent marker, enter the following information on the label:
 - ECM part number [Refer to the **Parts Information** section for the **CURRENT PART NUMBER**]
 - Calibration ID(s) [Refer to the **Calibration Identification Chart** for the **NEW CALIBRATION ID**]
 - Dealer Code
 - Repair Date
 - Change Authority [**This bulletin number**]
 - B. Affix the Authorized Modifications Label to the vehicle at the location shown in Figure 1. The Authorized Modifications Label is available through the MDC, P/N 00451-00001-LBL.
5. Test drive the vehicle to confirm proper vehicle operation.
