Passenger Side Floor Mat Bunching

Service Category Vehicle Interior

Section Interior Panels/Trim

Some 2013 model year LS 460 and LS 460L Rear Wheel Drive (RWD) vehicles may exhibit bunching in the passenger side front floor mat due to incorrectly mounted locating grommets. The grommets may have been installed too far apart, creating a slight bulge in the floor mat between the grommets when the floor mat is installed. Use the following procedure to address this condition.

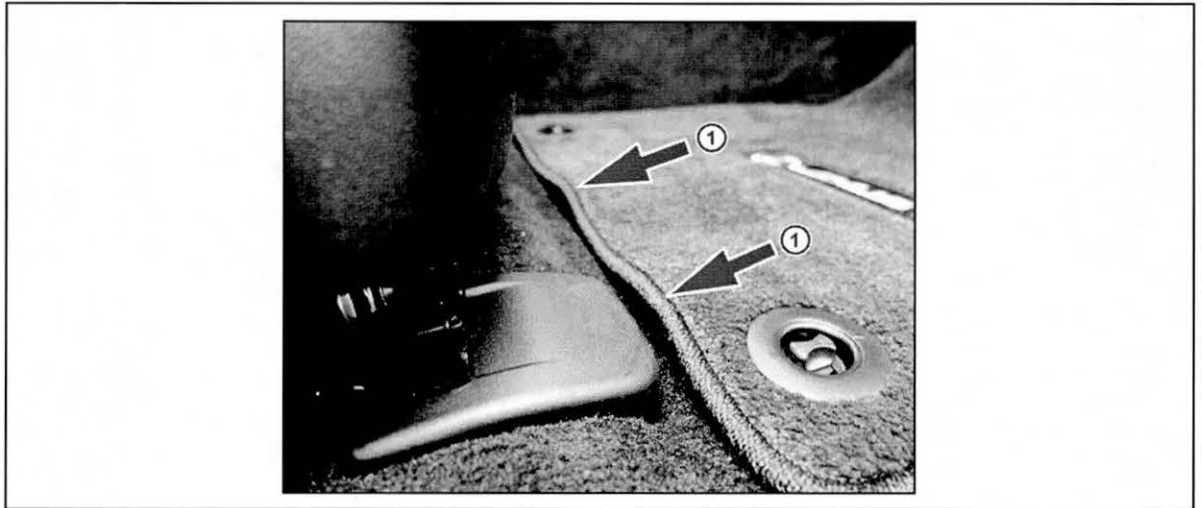
Figure 1.

Is the floor mat bunching?

1	Bunching Present
---	------------------

- **YES** – Proceed to step 2.

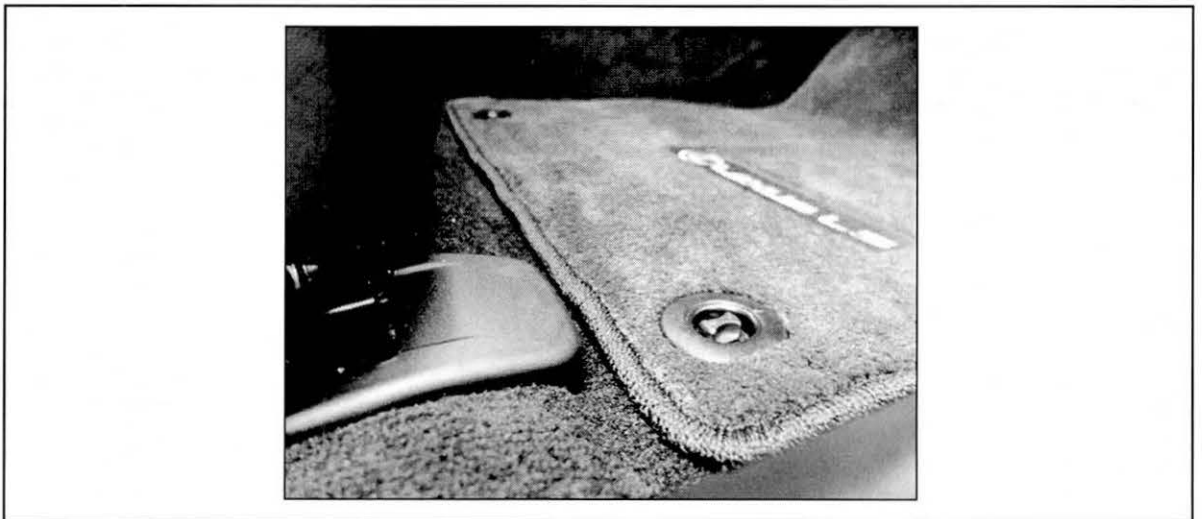
Figure 2.

- **NO** – The vehicle has the correct floor mat. Return vehicle to the customer.

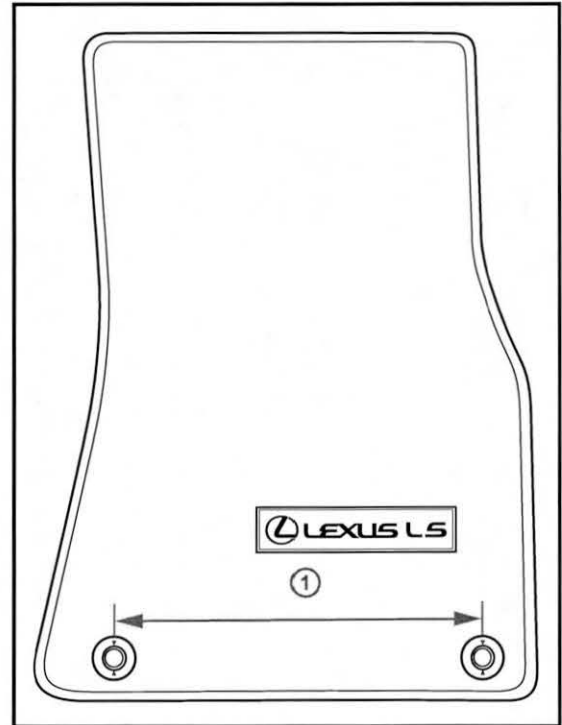
Figure 3.

2. Remove the floor mat and measure the distance between the 2 grommets as shown.

1 Distance Between Grommets

3. Confirm that the distance between the center points of the grommets is within the acceptable range.

Acceptable Range: 393 – 397 mm (15.47 – 15.63 in.)

- **YES** – Reinstall the original floor mats.
- **NO** – Replace the floor mat with the new service parts.

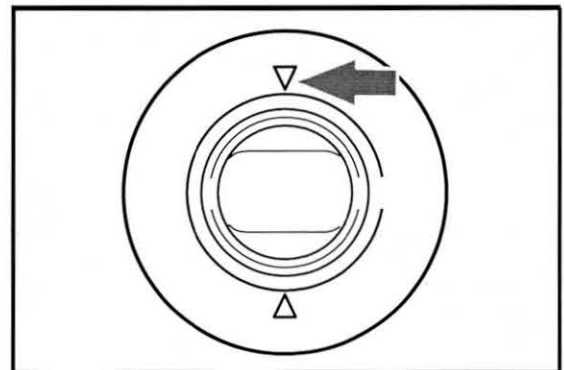
Be sure to measure between the reference arrows as shown in Figure 4.
