Occupant Classification Calibration Utility Error after Repair

2013-2014 GS Models 2013-2014 ES Models

2013-2014	GS350	2013-2014	ES300H
2014	ES350	2013-2014	GS450H

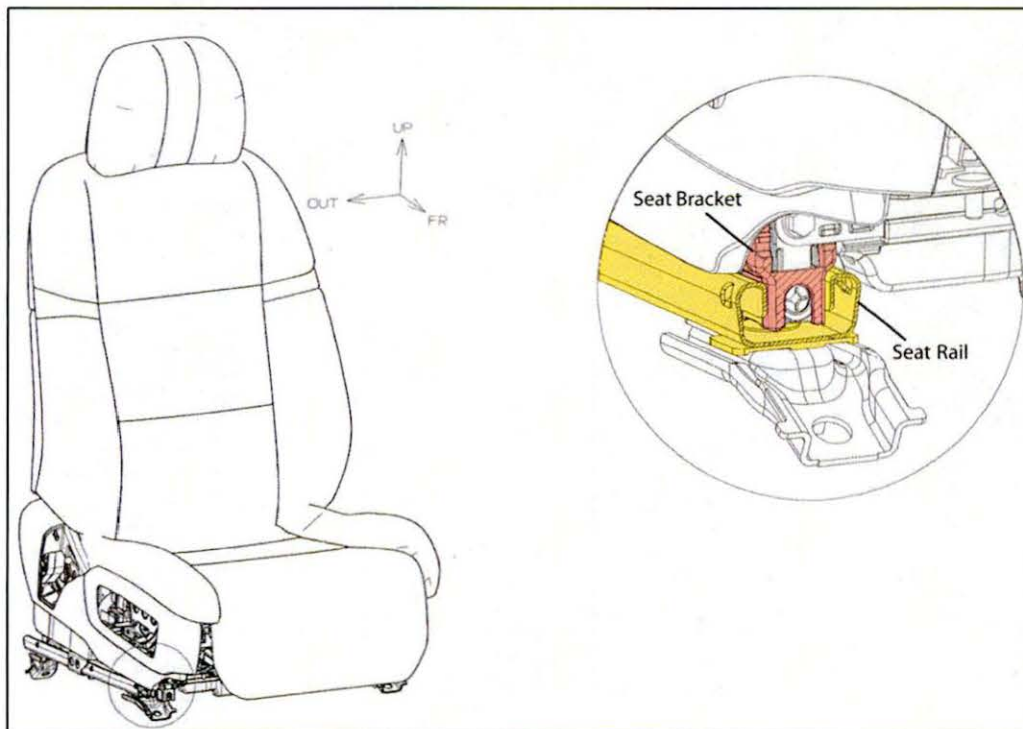
When performing the Zero Point Calibration & Sensitivity Check on the models noted above, an error will occur if user follows on-screen instructions. This issue is being investigated for release in a future software version.

Move the seat forward until the seat bracket and the seat rail are flush, as shown in the picture below. Failure to do this will result in the utility failing.
