NUMBER: 08-007-13 REV. A

RB5 RE2 Loss Of satellite Function, Sirius ID Number Missing

2012-****2013**** (JC) Journey

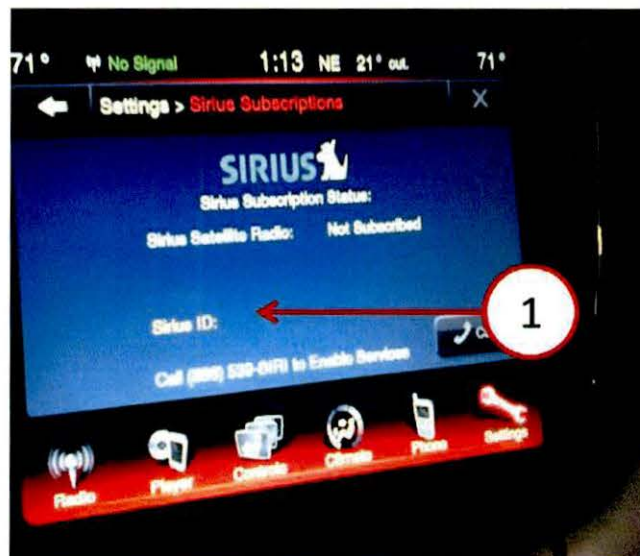
Fig. 1 Sirius ID Number Missing

A customer may experience a loss of satellite radio functions. ****On further inspection the Technician may note that the Sirius ID number is missing****.

1. **Are all satellite radio functions inoperative and is the Sirius ID number missing, see (Fig. 1).

1 - A Sirius ID number should always be in this location**.

- a. Yes <<< Replace the TGM, proceed to [Step #2](#).
 - b. No <<< Update the radio software, proceed to [Step #4](#).
2. Replace the TGM per TechConnect - 08 - Electrical/8E - Electronic Control Modules/MODULE, Telematics Gateway/Removal and Install.
