NUMBER: 08-023-13

GROUP: Electrical

RHW And RHP Navigation System Does Not Show The Proper Vehicle Location

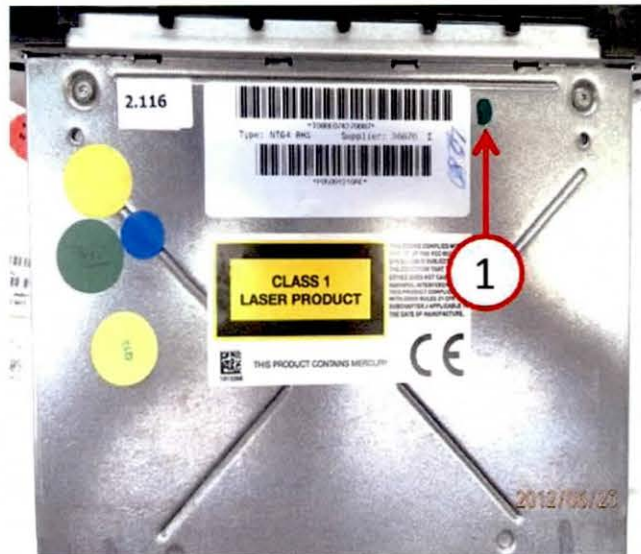
Fig. 1 Updated radios will have a painted green mark

1 - Location of green mark.

-
13. Does the radio have a green dot?
 - a. Yes >>> The updated radio has already been installed in this vehicle. Proceed to [Step #14](#).
 - b. No >>> The radio needs to be replaced, have the parts department order one from the exchange center. **Put the radio back into the vehicle and give it back to the customer. Once the dealer receive the radio, set up an appointment with the customer to install the updated part.**
