NUMBER: 08-026-13 REV. A

RA3 And RA4 Radio Enhancements

This bulletin involves upgrading the software on the RA3 or RA4 Radio.

2013 (DS) 1500 Ram Pickup

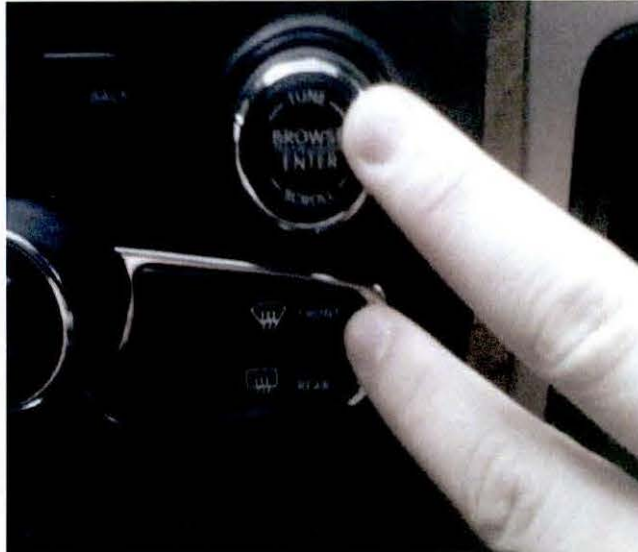
Fig. 1 Take Vehicle Out Of Ship Mode

1 - Press and hold these buttons, to put the vehicle in and out of ship mode.

- a. Yes >>> Proceed to [Step #5](#)
 - b. No >>> Proceed to [Step #6](#)
 5. Press and hold the 'Enter/Browse' button and the 'Front Defrost' (about 5 seconds) until "Ship Mode" is no longer displayed on the instrument cluster, see ([Fig. 1](#)).
