**NUMBER:** 08-029-13

UConnect Access Feature Cannot Be Successfully Registered

2013 (DS) Ram 1500 Pickup

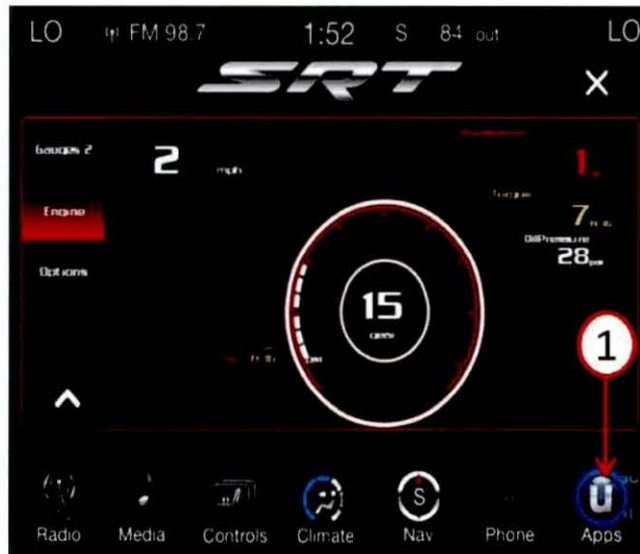
**Fig. 1 App Icon with Cell Bar Indicator**

1 - Need more than one bar for proper reset.

1. In order to successfully perform the reset, the vehicle must be receiving a 3G cellular signal greater than 1 bar. The Apps Icon located in the lower right corner of the display will indicate the signal strength (Fig. 1)

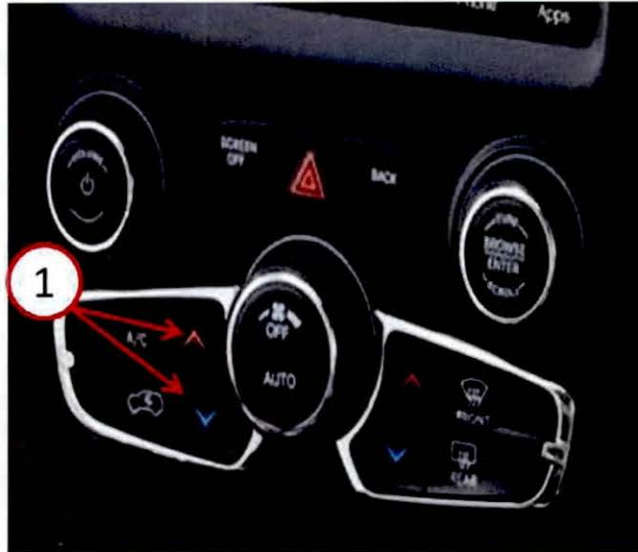
**Fig. 2 Entering Reset Mode**

1 - Press Up/Down Temp Controls Simultaneously for 5 Seconds

- 
2. Enter the Reset Menu by pressing and holding the up and down HVAC temperature control buttons simultaneously for 5 seconds. On dual zone systems press and hold the driver's side control buttons (Fig. 2)

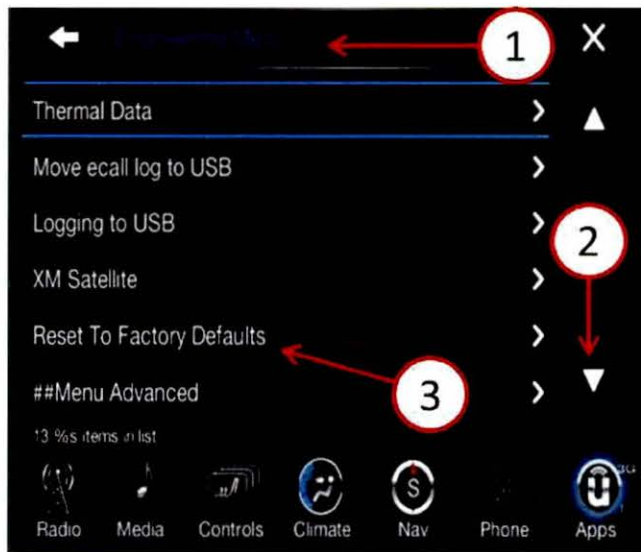
**Fig. 3 Engineering Menu**

1 - Reset Menu

2 - Scroll Down to Reset Factory Defaults

3 - Factory Reset Selection

3. Scroll down until "Reset to Factory Defaults" is displayed (Fig 3) and press Reset to Factory Defaults(Fig. 3)

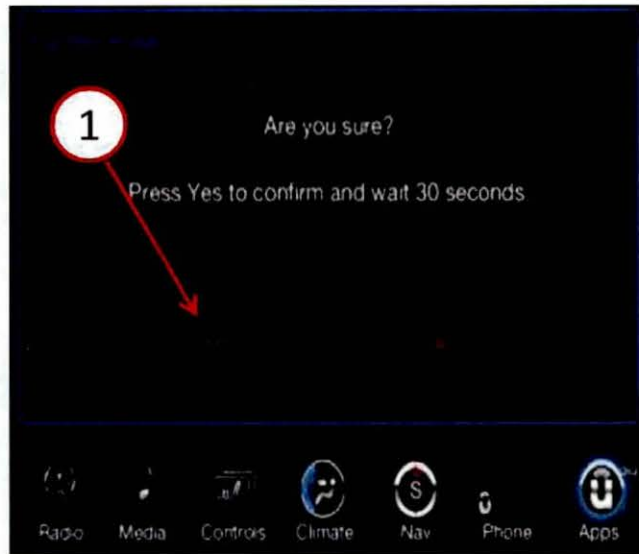
**Fig. 4 Factory Reset**

1 - Select Yes to Reset Radio

- The following Pop Up will appear, select "Yes" and wait approximately 30 seconds for the radio to reset (Fig. 4).

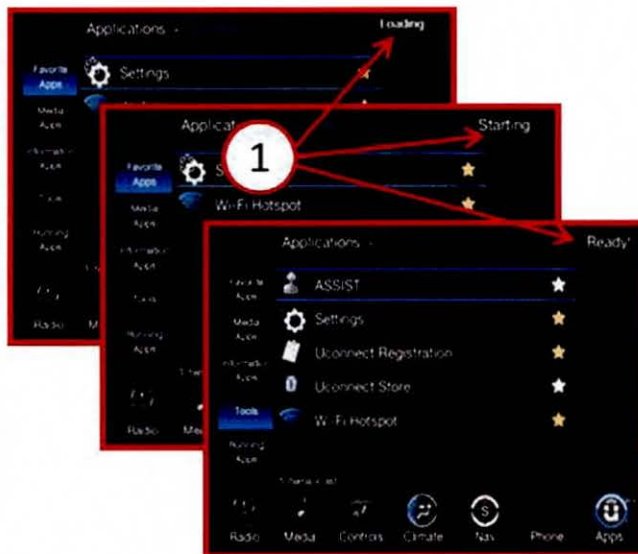
**Fig. 5 Applications loading**

1 - Loading, Starting and Ready

- Once the radio has powered back up, cycle the ignition off. To ensure that CAN bus has gone to sleep, wait until the USB/SD card slot LED ring goes dark. Then start the vehicle again and complete the 2nd ignition cycles.
- After the 2nd ignition cycle has been completed, turn the vehicle back on.
- When the radio restarts, press the Apps button and the following screen messages will be seen that confirms the unit has successfully been restored and the applications are loading (Fig. 5).
