NUMBER: 08-034-13

GROUP: Electrical

RA3 And RA4 Radio Enhancements

2013 (DX) 1500 Ram Pickup (Mexico Market Only)

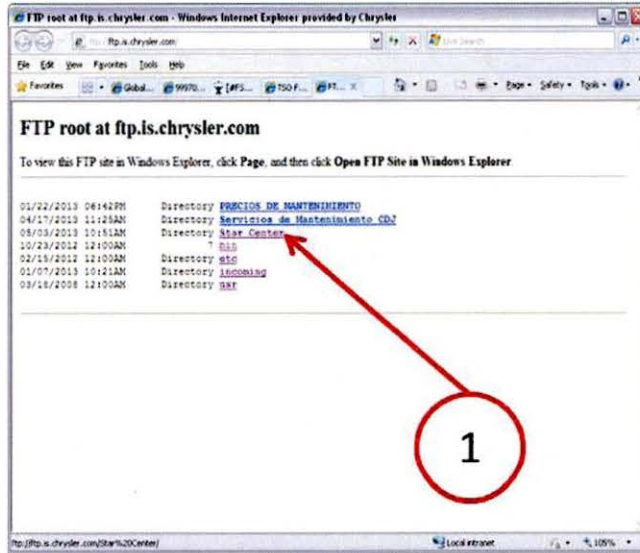
Fig. 1 FTP Site

1 - Star Center

4. Click on the Star Center directory (Fig. 1).

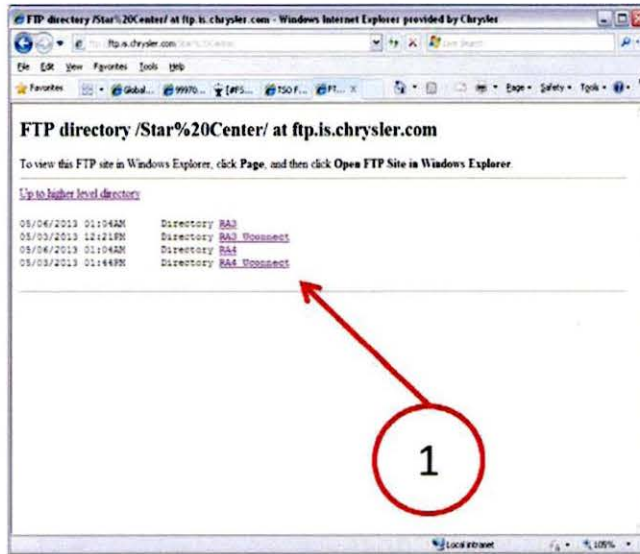
Fig. 2 FTP Site

1 - Radio Directory

5. Select Radio Directory(Fig. 2).

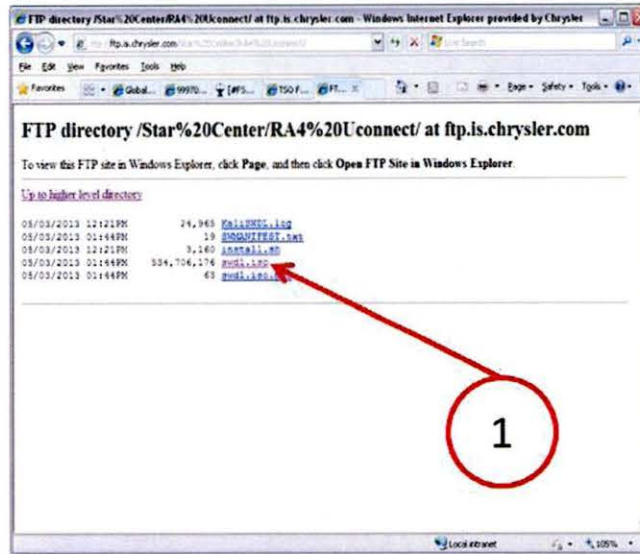
Fig. 3 FTP Site

1 - Flash File "swdl.iso"

6. Select "swdl.iso" flash file (Fig. 3).
