AB60F Transmission Clutch/Brake Damage

Service
Category Drivetrain

Section Automatic Transmission/Transaxle

YEAR(S)	MODEL(S)	ADDITIONAL INFORMATION
2008 – 2011	LX570	Engine(s): 3UR Transmission(s): 6AT VDS(s): HY00W, HY7AX

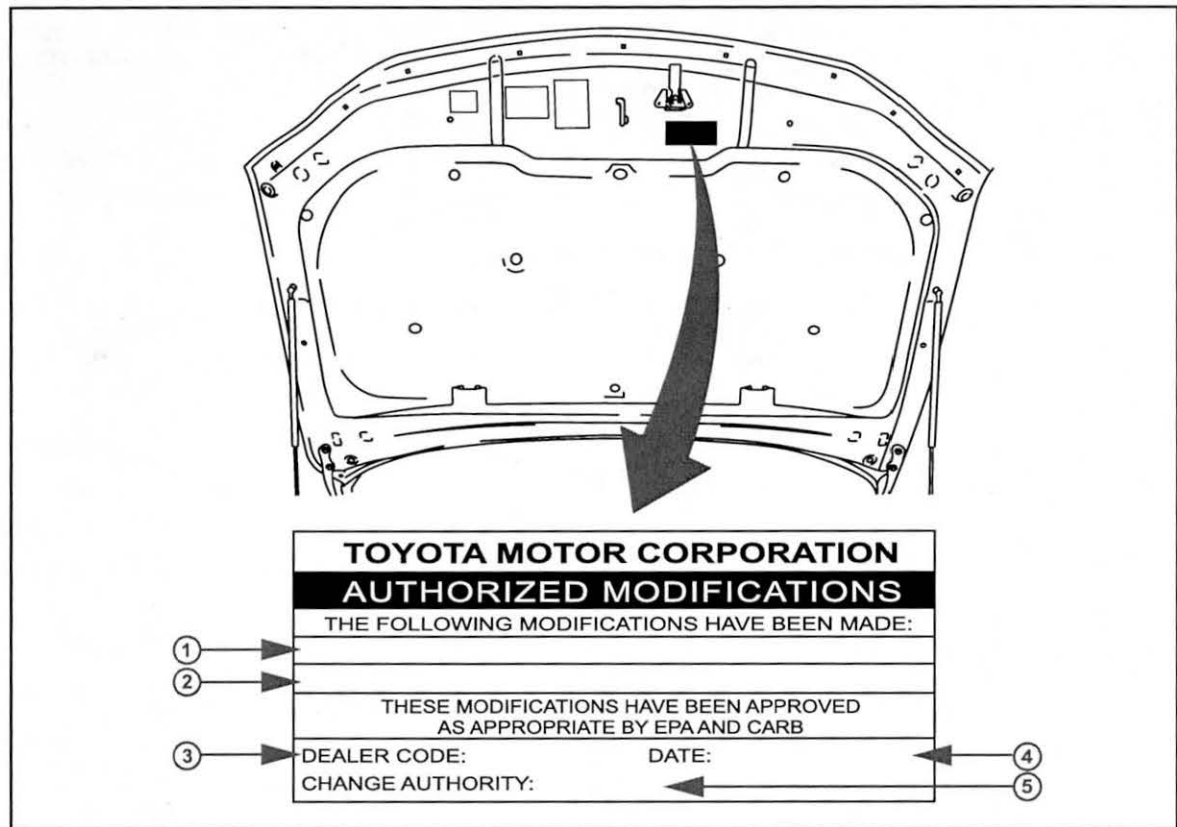
Figure 1. Location of Authorized Modifications Label on 2008 – 2011 LX 570

1	Replacement ECM (PCM) Part Number (i.e., 89661-60G65)
2	New Calibration ID(s) (i.e., 360C2500)
3	Dealer Code

4	Date Completed
5	This SB Number

- A. Check for the Authorized Modifications Label affixed to the vehicle in the location shown in Figure 1. Confirm if the ECM (PCM) calibration has been updated. If the calibration ID listed is NOT the latest ECM (PCM) calibration, go to step B.

B. Affix the Authorized Modifications Label to the vehicle at the location shown in Figure 1. The Authorized Modifications Label is available through the MDC, P/N 00451-00001-LBL.
