# Navigation System Firmware Update

YEAR(S)	MODEL(S)	ADDITIONAL INFORMATION
2013	GS350, GS450H, LX570, RX350, RX450H

## Introduction

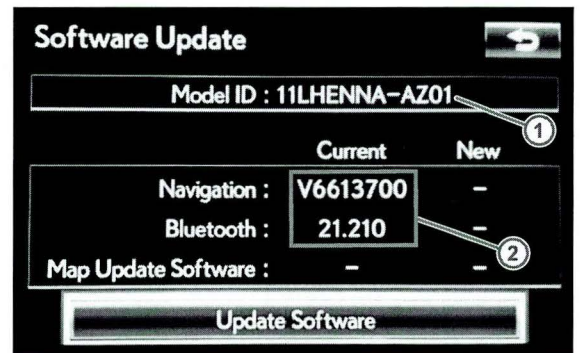
Figure 5.

1	ID Varies According to Vehicle
2	Current Version Is Displayed

7. Connect USB memory stick for the update.

- If the current version is “V6613850” or greater, STOP — This bulletin does NOT apply.
- If the current version is less than “V6613850”, proceed to step 8.

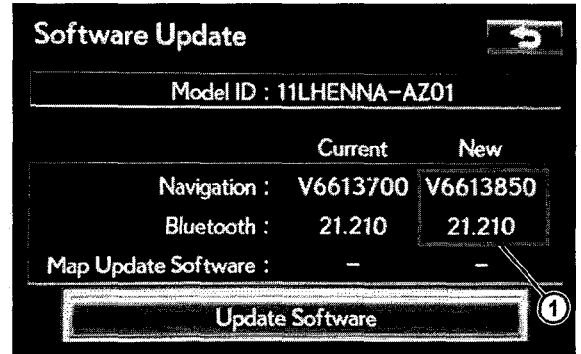
Figure 6.

1 | Version to Be Updated Is Displayed

8. Press *Update Software*.
