Service Bulletin

Bulletin No.: PIT5234A

Subject: Ignition Key Cannot Be Turned

Models: 2014 Chevrolet Silverado 1500
2014 GMC Sierra 1500

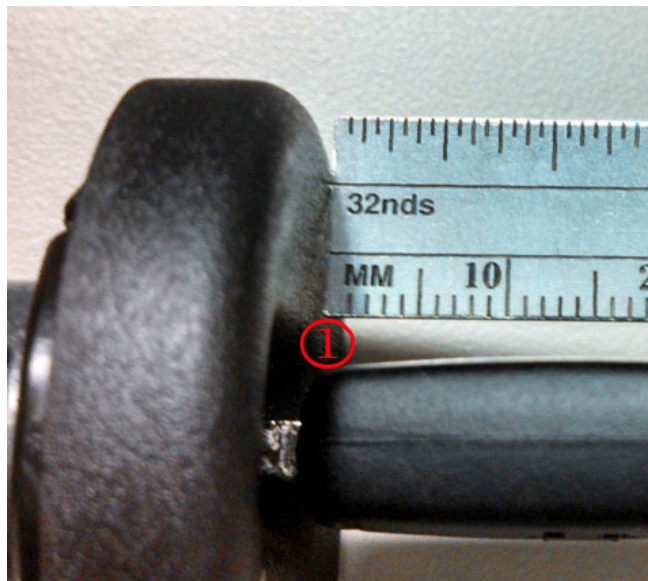
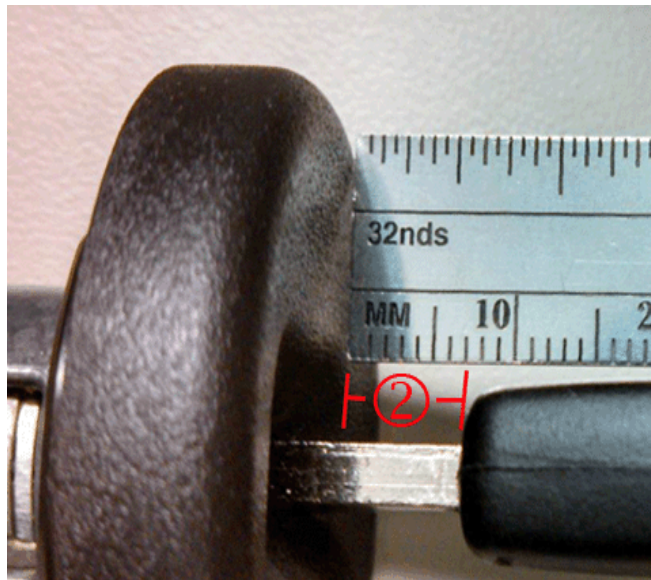
3621596

1. Insert key into ignition and confirm key will not turn.
2. With key inserted, measure the key to the cylinder, shown below is the correct (1) and incorrect (2) insertion measurements.

- Important:** If the insertion distance is correct, do not perform the following procedure and proceed to Condition #2.
3. The ignition lock cylinder will need to be replaced to correct this issue, if the key is not going in fully. To remove and replace the ignition lock cylinder, it must be rotated to the start position so the ignition cylinder retaining tab can be pressed down. Since the lock cylinder will not rotate continue with the following steps.
 4. Obtain a new key that is cut to the vehicle. Reference the latest version of TSB 09-00-89-029: Key Cutting Procedure for Obtaining Replacement Key. The purpose of ordering a new key is so that the original customer's keys are left intact.
 5. Shorten the key shank by grinding or cutting 6-7mm (1/4 inch) off the tip of the key.
