Service Bulletin

Bulletin No.: PIT5234

Subject: Ignition Key Cannot Be Turned

Models: 2014 Chevrolet Silverado 1500
2014 GMC Sierra 1500

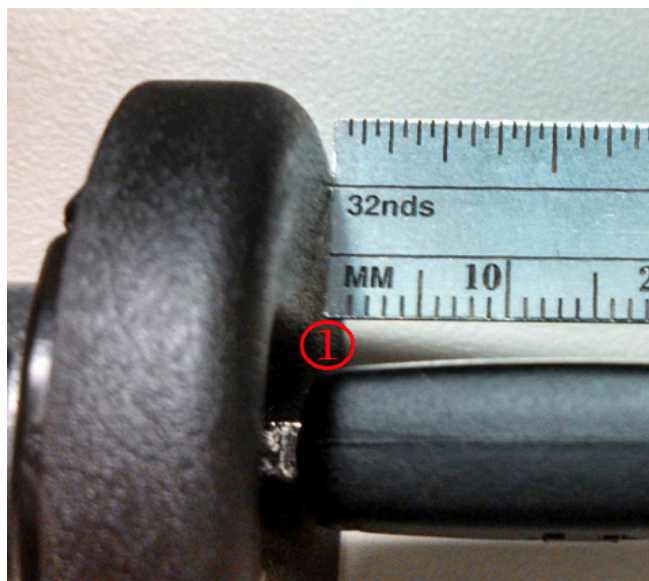
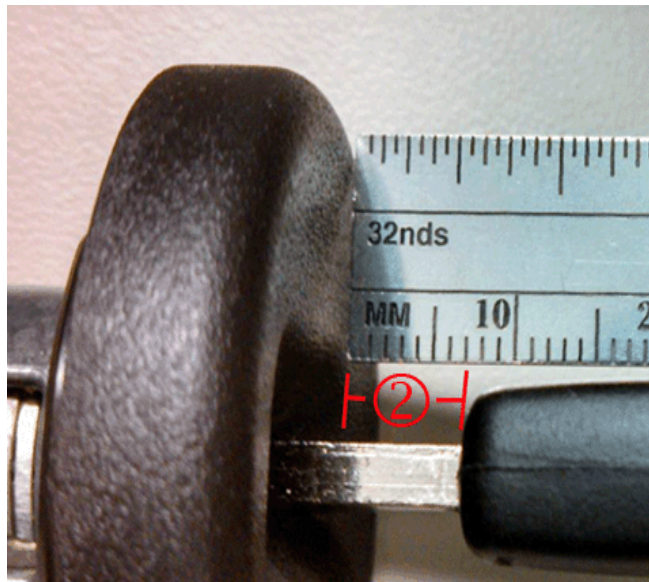
3621596

1. Insert key into ignition and confirm key will not turn.
2. With key inserted, measure the key to the cylinder, shown below is the correct (1) and incorrect (2) insertion measurements.

- Important:** If the insertion distance is correct, do not perform the following procedure and proceed to Condition #2.
3. The ignition lock cylinder will need to be replaced to correct this issue, if the key is not going in fully. To remove and replace the ignition lock cylinder, it must be rotated to the start position so the ignition cylinder retaining tab can be pressed down. Since the lock cylinder will not rotate continue with the following steps.
 4. Obtain a new key that is cut to the vehicle. Reference the latest version of TSB 09-00-89-029: Key Cutting Procedure for Obtaining Replacement Key. The purpose of ordering a new key is so that the original customer's keys are left intact.
 5. Shorten the key shank by grinding or cutting 6-7mm (1/4 inch) off the tip of the key.

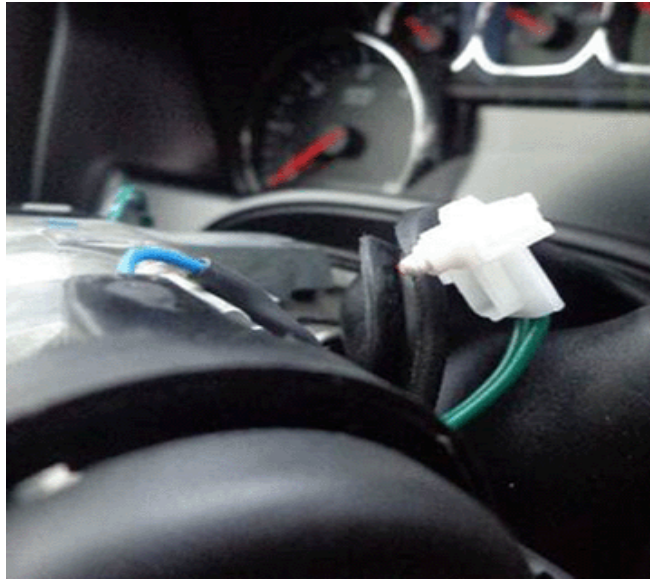
3620961

Important: If you don't remove the sensor, you will shear the sensor off during removal.

8. Remove the key reminder chime sensor.
