Service Bulletin

Bulletin No.: PIT5226A

Subject: Rear Sliding Glass Inoperative or Noisy (Pulley Cover Separation)

Models: 2014 Chevrolet Silverado LD 1500
2014 GMC Sierra LD 1500

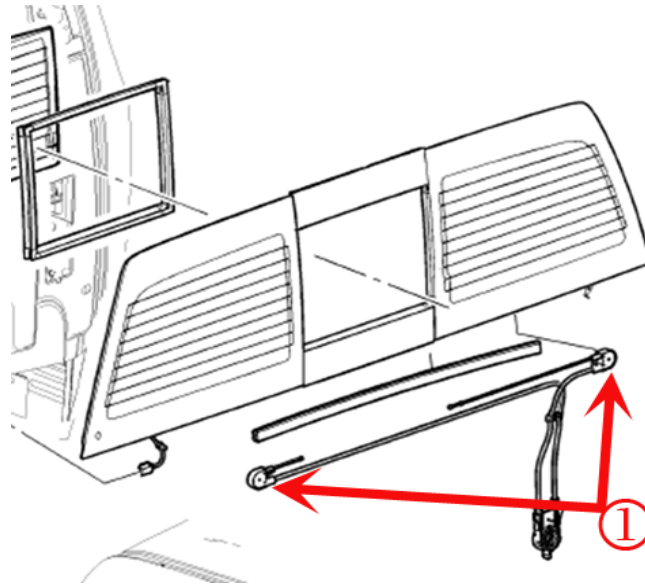
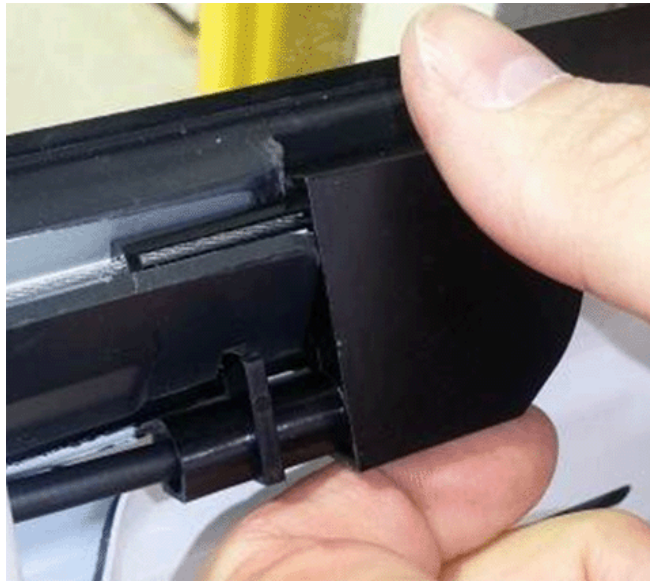
Some owners may comment on the rear sliding glass being inoperative or noisy when operated. This could be caused by the cable pulley cover becoming separated, see photos below.

Do NOT replace the complete back sliding glass assembly for this issue. Do replace the rear sliding window regulator assembly (GM part number 22341999).

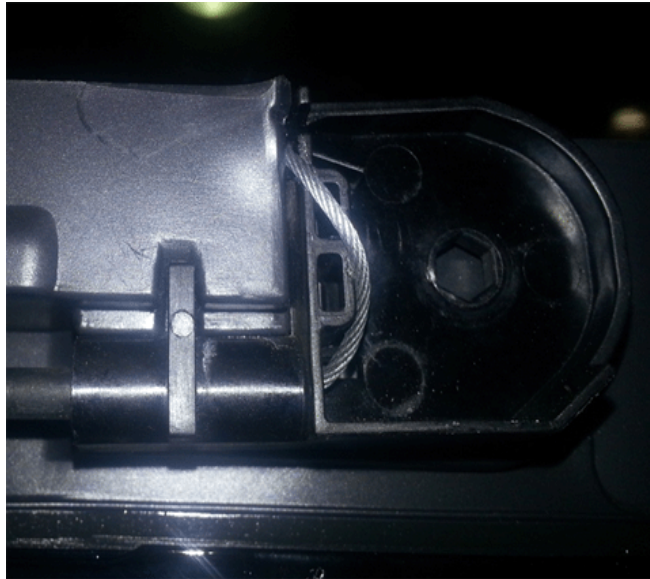
3520533

If the cable pulley cover completely disengages, the pulley can come off and cause the cable to bind, see photo below.
