# Service Bulletin

Bulletin No.: PIT5225A

**Subject:** Front Door Window Belt Molding Retainer Bolt Corrosion

**Models:** 2014 Chevrolet Silverado 1500  
2014 GMC Sierra 1500  
Built prior to 8/13/2013

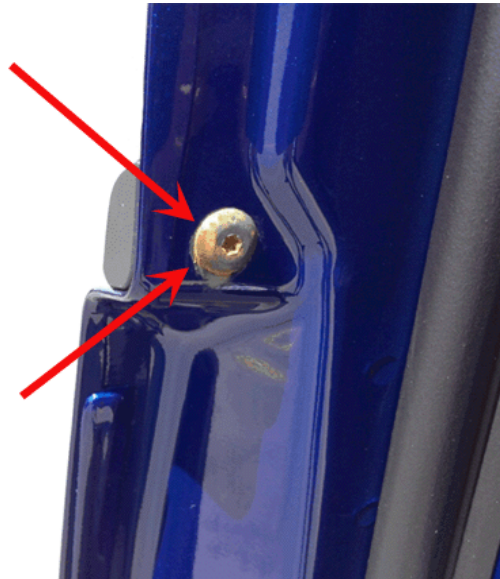
3605356

Some owners may comment that the front side door window belt molding retainer bolt is corroded, see photo below.

To correct this issue, replace the Bolt with GM Part # 11515397. Apply Red Thread Adhesive (GM Part # 89021297, Canada Part # 10953488 or equivalent) to the bolt threads and tighten to 27 lb-in (3 N-m).
