Service Bulletin

Bulletin No.: PIT5225

Subject: Front Door Window Belt Molding Retainer Bolt Corrosion

Models: 2014 Chevrolet Silverado 1500

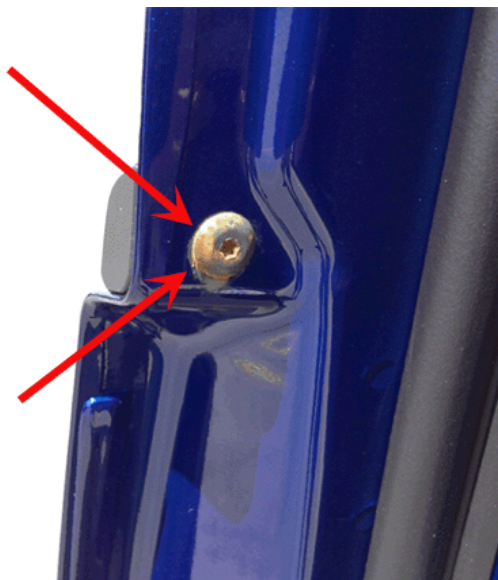
3605356

Some owners may comment that the front side door window belt molding retainer bolt is corroded, see photo below.

To correct this issue, replace the Bolt with GM Part # 11515397. Apply Red Thread Adhesive (GM Part # 89021297, Canada Part # 10953488 or equivalent) to the bolt threads and tighten to 27 lb-in (3 N-m).
