Technical product information

Topic	Rear door blind fails to deploy – Outer frame finisher baulking
Market area	Worldwide Bentley (1WBE)
Brand	Bentley
Transaction No.	2035539/1
Level	EH
Status	Approval
Release date

Transaction No.: 2035539/1

Rear door blind fails to deploy – Outer frame finisher baulking

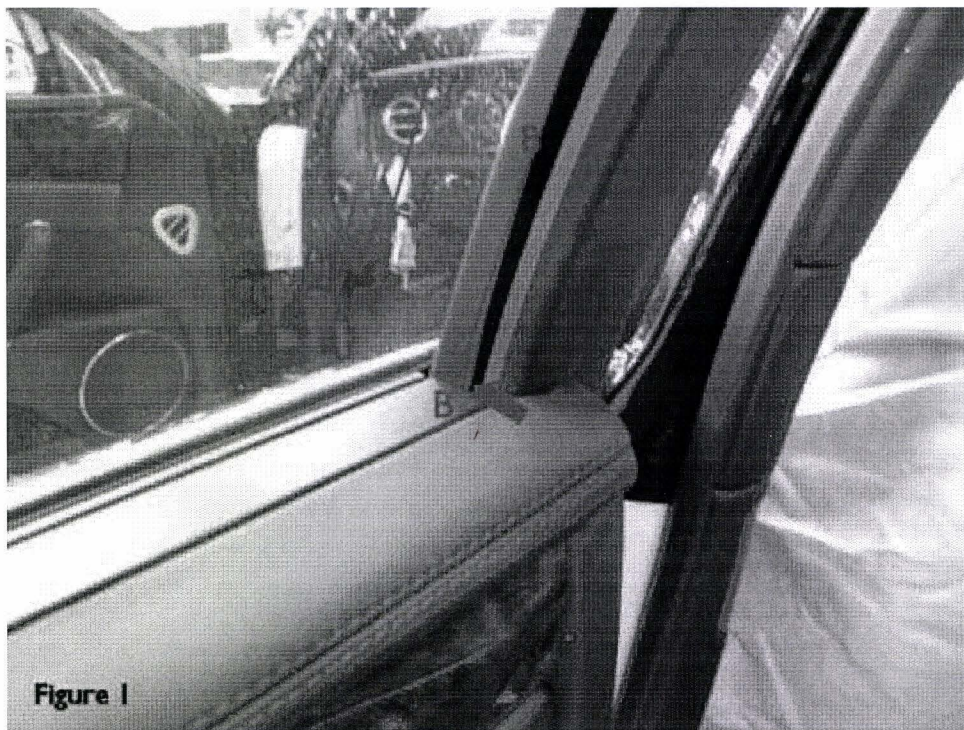
1.

The outer frame finisher can become dislodged, assuming a position that partially covers the channel from which the rear door blind deploys. When this is the case the blind will be baulked and not deploy. A revised outer frame finisher is available for fitment on occurrence of this failure. When this failure occurs carry out the following procedure on both rear doors.

In the event of a rear door blind failing to deploy check the position of the outer frame finisher, figure 1 shows the finisher in the fail position. If the finisher (A) has moved towards the rear blind deployment slot then push the outer frame finisher back to its design position line (B) and re test the rear door blind function (see Figure 1). If the blind subsequently works then carry out the following procedure to fit the latest revised outer frame finisher which will ensure the finisher maintains its design position. The procedure, if required on one rear door, should be performed on both rear doors.
