Workshop Campaign E797

Transaction No.: 2035677/1

GT V8T GTC V8T HVAC refrigeration pipe - clip replacement - Corrosion
(SC13/20)

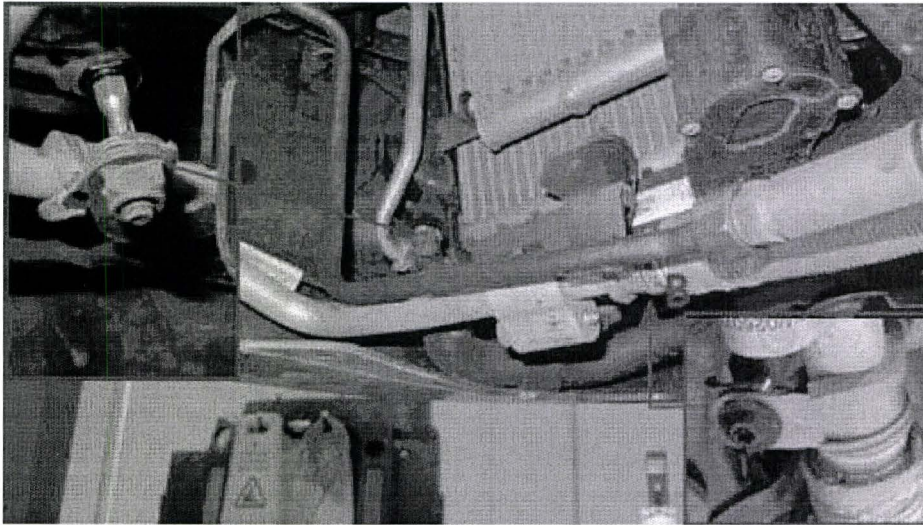
Figure 1

5. Referencing figure 1 identify the two 'P' clips (A and B) located in the front left hand wheel arch that require replacement
6. **Note:** A number of later cars in this campaign are expected to already have the correct clips fitted, figure 1 depicts the correct clips identified by a red band printed on the clip insert. Pipes fitted with clips carrying the red band do not required inspection and therefore will not require clip replacement.
7. Using a T30 bit loaded into a ratchet spanner remove the fastener securing P clip (A). Remove and discard clip A (see Figure 1)
8. Remove and discard clip B (see Figure 1)

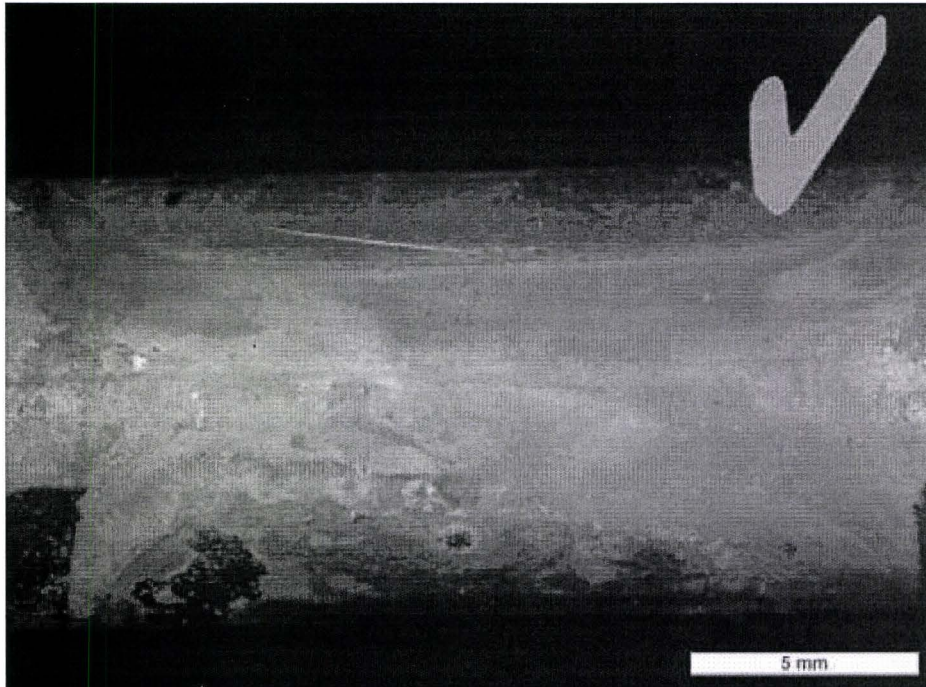
Figure 2

9. The two locations from which the clips have been removed should now be inspected for surface corrosion, a mirror may aid inspection. Discolouration and light oxidation on the surface of the pipe is not detrimental and does not necessitate pipe replacement (see Figure 2). If the pipe surface shows signs of extensive corrosion and pitting (see Figure 3) then that pipe should be replaced
10. On cars where the pipe is serviceable, figure 2, fit two replacement clips. For position A fit new clip part number RSGUV1.10-15W1, in position B fit new clip part number RSGUV1.18-15W1. If either

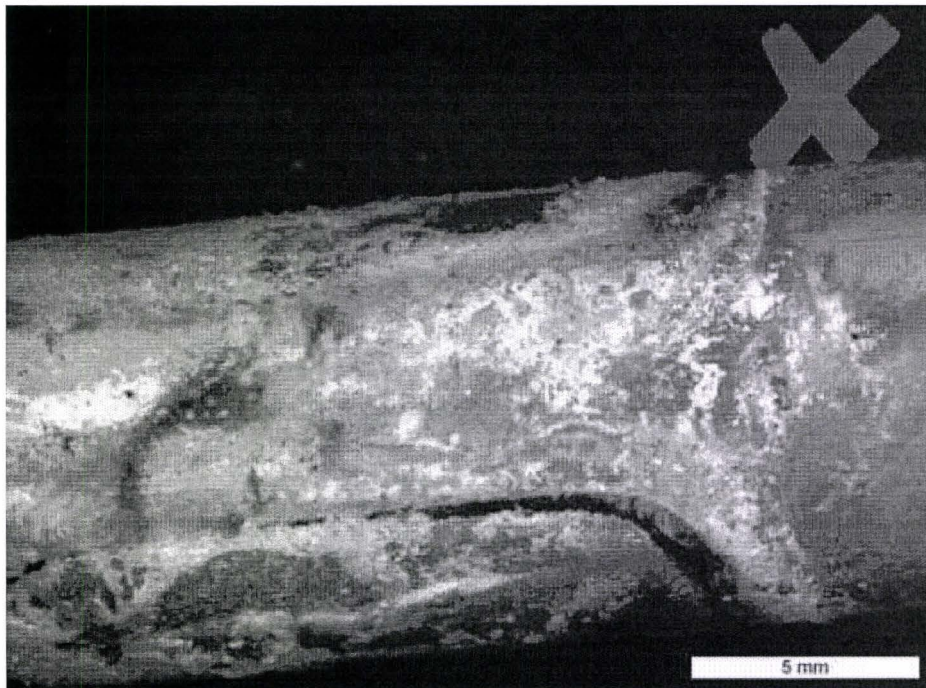
Figure 3

- Before working on the refrigeration system, read and understand the Refrigeration system – safety and general information detailed in the workshop manual Rep. Gr.87
1. This procedure is only to be performed if either pipe has extensive surface corrosion at the clipping points (see Figure 3)
 2. Note: If the refrigeration system is left open for more than 30 minutes the accumulator will have to be replaced
 3. Discharge the refrigerant from the system Rep.Gr.87 Refrigeration system – To discharge and charge

pipe is found to have extensive corrosion then both pipes should be replaced before replacing the clips, in this case follow the Air conditioning pipe replacement procedure detailed below.
