Topic	Battery monitor control unit – software update (SC13/21)
Market area	Worldwide Bentley (1WBE)
Brand	Bentley
Transaction No.	2035952/2
Campaign number	E798
Note	
Type	Workshop Campaign
US code

Workshop Campaign E798

Battery monitor control unit – software update (SC13/21)

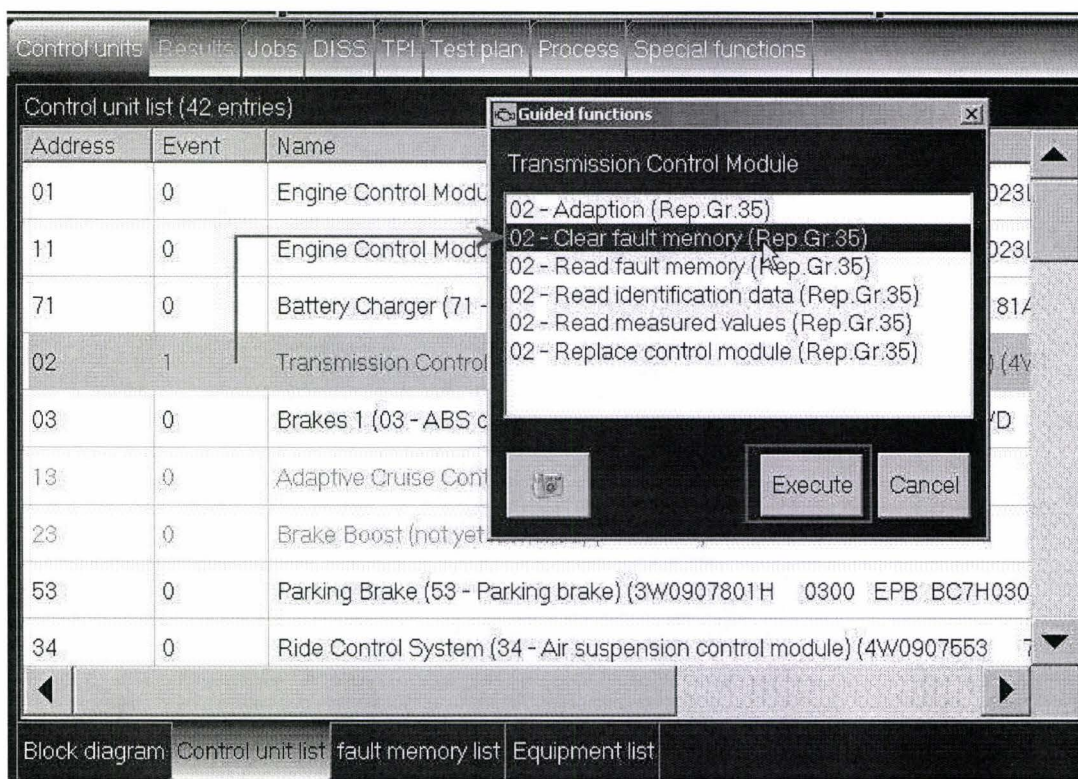
Figure 9

17. Use *Guided Fault Finding* in Offboard Diagnostic Information System to carry out a complete diagnostic sweep of the vehicle, clearing any fault codes generated as a result of performing this campaign. NOTE: Due to the fault codes induced as a result of this software update the vehicle ignition status will visible to the VAS tester during this initial guided fault finding control module sweep therefore click continue at ignitions status prompts.

18. NOTE 2: It is possible that an engine or transmission fault code may require guided fault finding to be used directly in that specific control module to clear the fault code (see Figure 9)
19. On completion apply a blue campaign completion mark (see Figure 10)
