NUMBER: 08-049-13 REV. A

RA3 And RA4 Radio Enhancements

This bulletin involves upgrading the software on the RA3 or RA4 Radio.

2013	(DS)	1500 Ram Pickup
2014	(WK)	Grand Cherokee

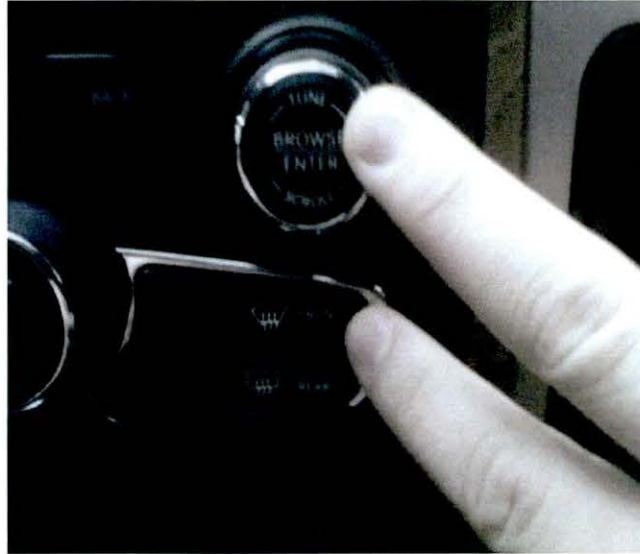
Fig. 1 Take Vehicle Out Of Ship Mode

1 - Press and hold these buttons, to put the vehicle in and out of ship mode.

- a. Yes >>> Proceed to [Step #5](#)
 - b. No >>> Proceed to [Step #6](#)
 5. Press and hold the 'Enter/Browse' button and the 'Front Defrost' (about 5 seconds) until "Ship Mode" is no longer displayed on the instrument cluster, see ([Fig. 1](#)).
