NUMBER: 08-049-13 REV. B

GROUP: Electrical

RA3 And RA4 Radio Enhancements

This bulletin involves upgrading the software on the RA3 or RA4 Radio.

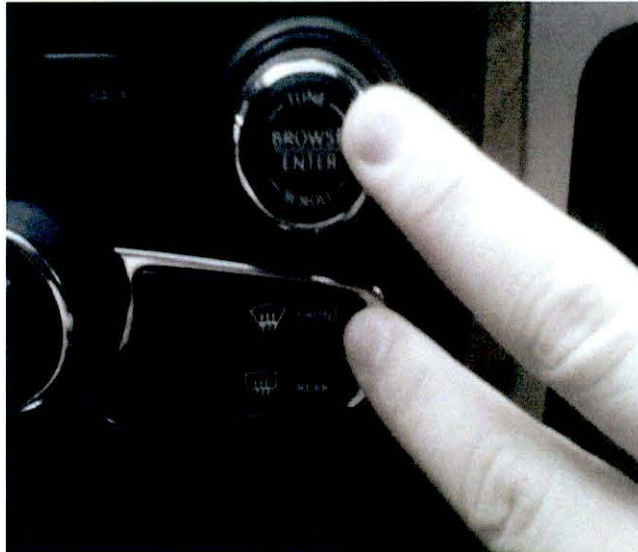
Fig. 1 Take Vehicle Out Of Ship Mode

1 - Press and hold these buttons, to put the vehicle in and out of ship mode.

3. Turn the engine on and check if the vehicle is still in ship mode. This will be displayed in the Electronic Vehicle Information Center (EVIC).
4. The vehicle must be in Customer Mode to update the radio. Is the vehicle in Ship Mode?
 - a. Yes >>> Proceed to [Step #5](#)
 - b. No >>> Proceed to [Step #6](#)
5. Press and hold the 'Enter/Browse' button and the 'Front Defrost' (about 5 seconds) until "Ship Mode" is no longer displayed on the instrument cluster, see ([Fig. 1](#)).
