**NUMBER:** 08-049-13 REV. C

RA3 And RA4 Radio Enhancements

This bulletin involves upgrading the software on the RA3 or RA4 Radio.

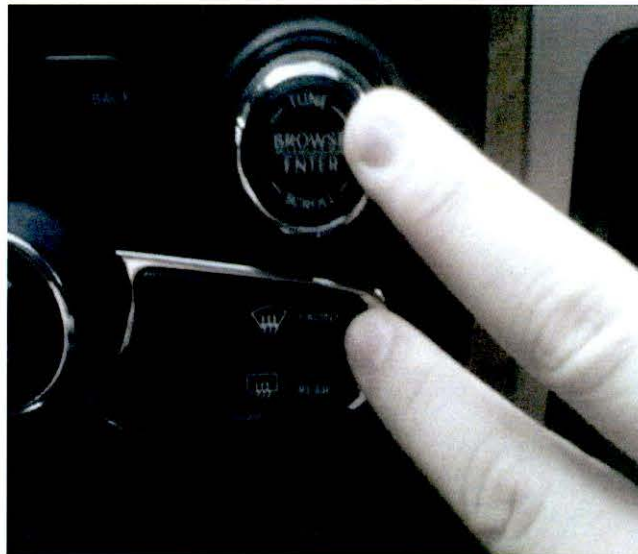
**Fig. 1 Take Vehicle Out Of Ship Mode**

1 - Press and hold these buttons, to put the vehicle in and out of ship mode.

- a. Yes >>> Proceed to [Step #5](#)
    - b. No >>> Proceed to [Step #6](#)
  5. Press and hold the 'Enter/Browse' button and the 'Front Defrost' (about 5 seconds) until "Ship Mode" is no longer displayed on the instrument cluster, see ([Fig. 1](#)).
