NUMBER: 08-049-13 REV. G

GROUP: Electrical

DATE: December 13, 2013

RA3 RA4 RJ3 RJ4 RG3 RG4 Radio Enhancements

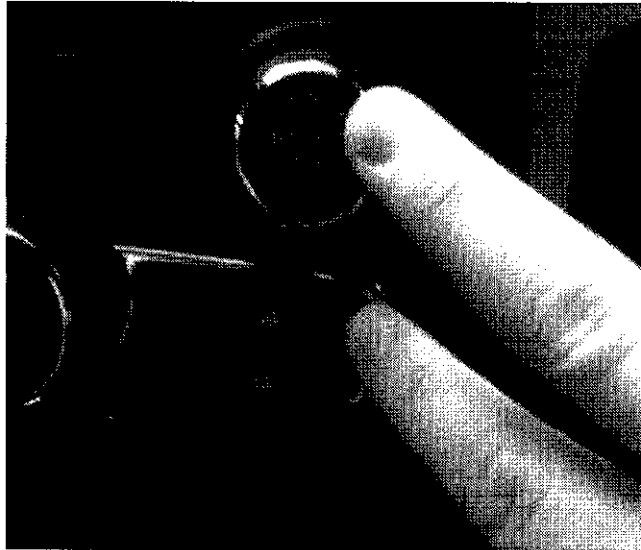
Fig. 2 Take Vehicle Out of Ship Mode

1 - Press and hold these buttons, to put the vehicle in and out of ship mode.
