NUMBER: 08-049-13

GROUP: Electrical

RA3 And RA4 Radio Enhancements

2013	(DS)	1500 Ram Pickup
2014	(WK)	Grand Cherokee

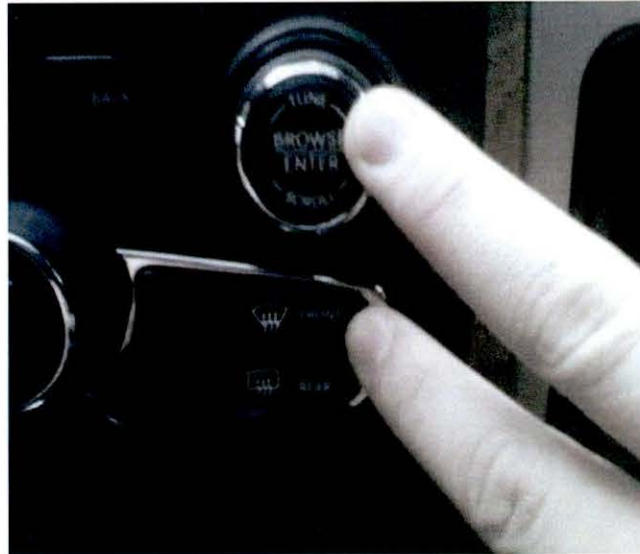
Fig. 1 Take Vehicle Out Of Ship Mode

1 - Press and hold these buttons, to put the vehicle in and out of ship mode.

3. Turn the engine on and check if the vehicle is still in ship mode. This will be displayed in the Electronic Vehicle Information Center (EVIC).
4. The vehicle must be in Customer Mode to update the radio. Is the vehicle in Ship Mode?
 - a. Yes >>> Proceed to [Step #5](#)
 - b. No >>> Proceed to [Step #6](#)
5. Press and hold the 'Enter/Browse' button and the 'Front Defrost' (about 5 seconds) until "Ship Mode" is no longer displayed on the instrument cluster, see ([Fig. 1](#)).
