NUMBER: 08-050-13

RE2 RE3 RE6 RB4 RB5 RB6 Radio Enhancements

This Bulletin involves updating the radio's software and vehicles equipped with navigation (RB4, RB5 and RB6) the navigation map software will be update.

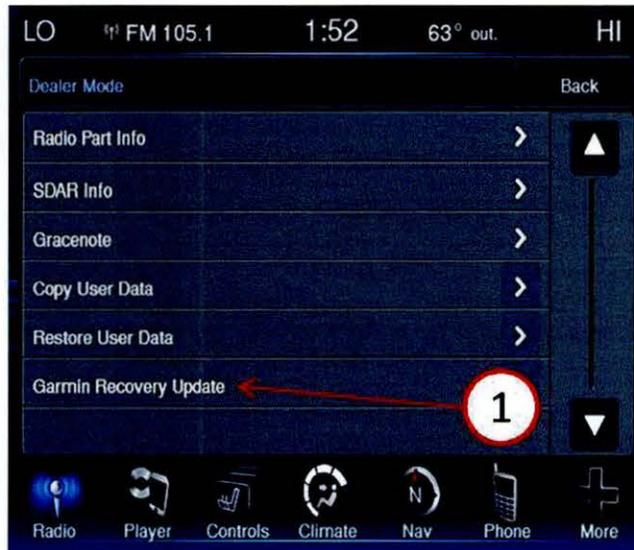
Fig. 1 Press Garmin Recovery Update to begin update

1 - Press soft key to begin

6. When the update is completed, the screen will read "Reflash Successful". Touch the screen and the radio will reboot.
7. The screen will now show the old and new software, press "No" on the screen to eject the disc.
8. Does this vehicle have a RE2, RE3 or RE6 radio?
 - a. Yes <<< The bulletin has been completed, proceed to [Step #16](#)
 - b. No <<< Map updates needs to be performed, proceed to [Step #9](#)
9. Put the radio into dealer mode by press the drives Temp up and down and the front defrost all at the same time until the dealer mode screen is displayed.
10. Press the soft key "Garmin Recovery Update" to begin the navigation update, see (Fig. 1)

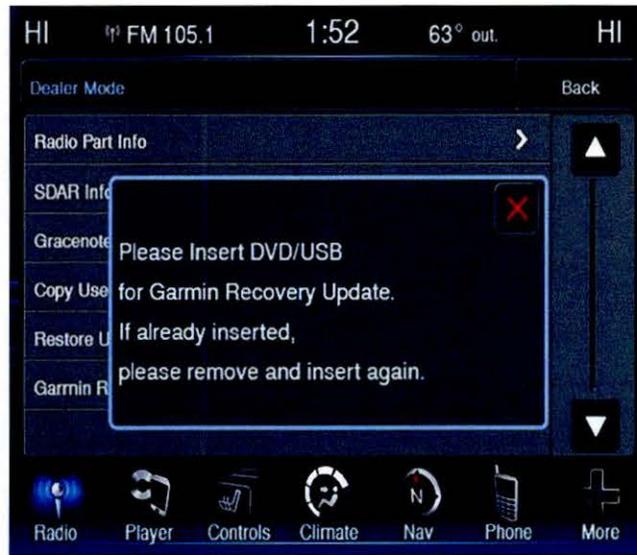
Fig. 2 Insert update when this screen is displayed

1 - Insert the update disc into the CD drive

-
11. To update the navigation system, insert the disc into the CD drive, see(Fig. 2).

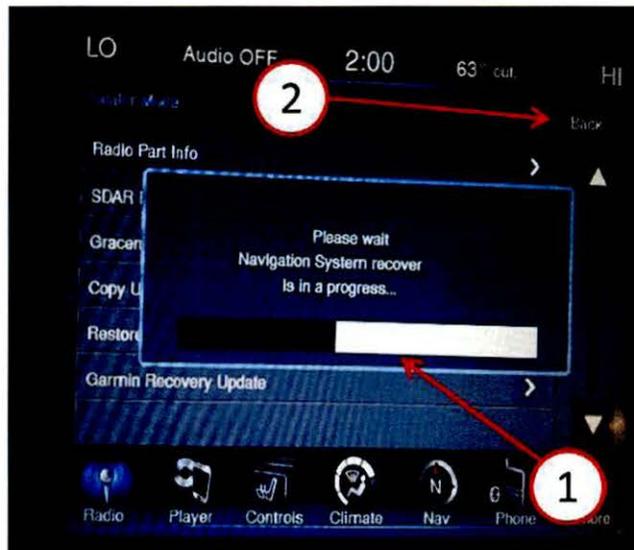
Fig. 3 This screen will be displayed next

- 1 - Pop up
 - 2 - Soft key, back button
-

-
- 12. This is the first step in the update, System recover. When this part is done the pop up will no longer be displayed. This will only take a few minutes.
 - 13. To continue press the "Back" soft key in the upper left hand corner of the screen, see (Fig. 3).

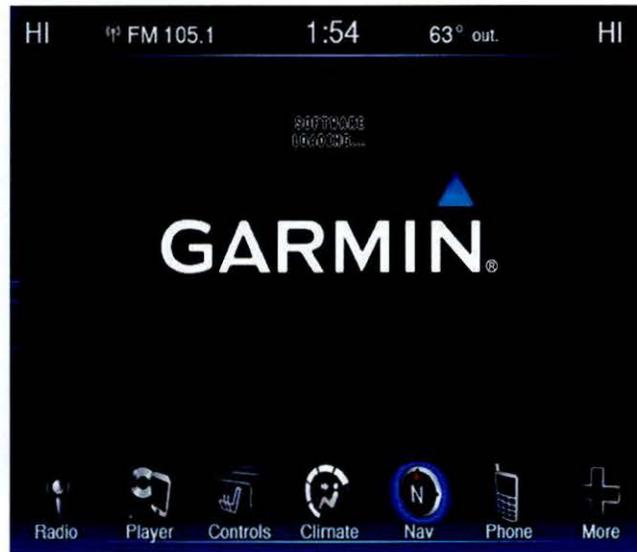
Fig. 4 This screen will be displayed next

1 - Loading software

14. This screen will be displayed when the update is being down loaded, see (Fig. 4)

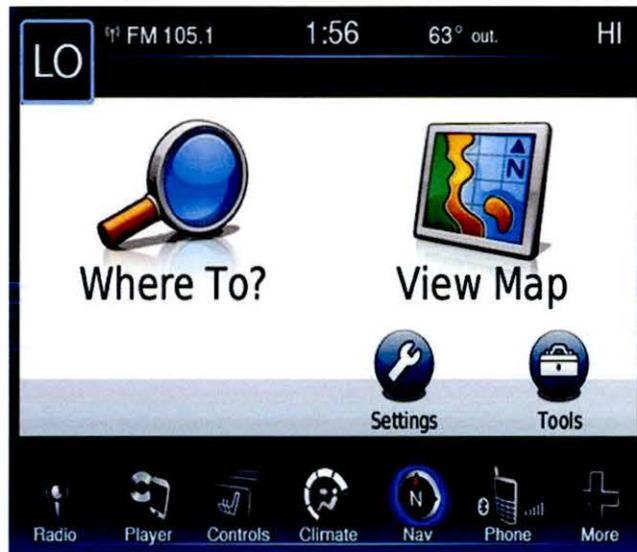
Fig. 5 Update is completed

1 - Navigation has been updated

15. When the software has completed down loading, the screen will change to the Garmin main screen, see(Fig. 5).
