NUMBER: 08-058-13

GROUP: Electrical

After Radio Replacement Cannot Register Uconnect Access or Critical Vin Error Message Is Displayed

2013	(DS)	Ram 1500 Pickup
2014	(ZD)	Viper
2013	(D2)	RAM 3500 Pickup
2013	(DD)	RAM 3500 Cab Chassis
2013	(DJ)	RAM 2500 Pickup
2013	(DP)	RAM 4500/5500 Cab Chassis
2014	(WK)	Grand Cherokee
2014	(KL)	Cherokee

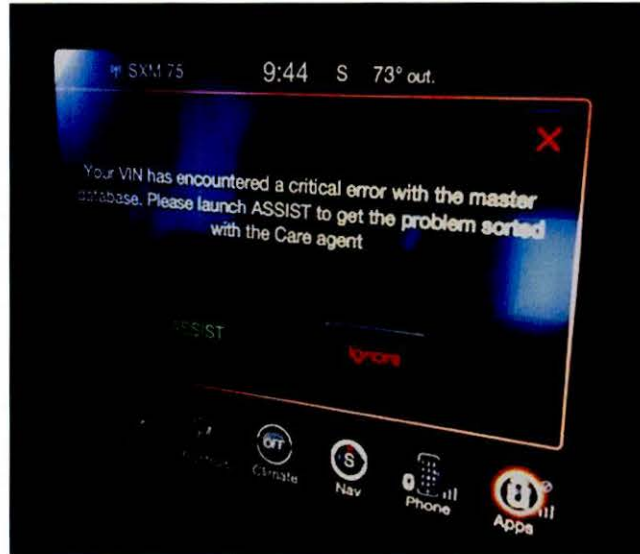
Fig. 1 Critical Error Message

In some cases (poor cell coverage etc.) the consistency check may fail. If this occurs customers that are registered will not be able to log into the Uconnect Access app's, and if not registered, will not be able to register. In some cases a "Critical VIN Error" message may be seen on the Head Unit, (Fig. 1).

1 - May be display when error occurs

6. If the registration selection does not disappear, an outbound Uconnect Care call cannot be made from the vehicle, or "Critical VIN Error" is seen contact Uconnect Care at 1-855-792-4241. They will provide direction and additional help to resolve the connectivity concern.
7. Connectivity Verification is completed.
8. Press the registration selection and follow the steps up to the point of inserting an e-mail. If accessing the registration process is unsuccessful or "Critical VIN Error" is seen contact Uconnect Care at 1-855-792-4241. They will provide direction and additional help to resolve the connectivity concern.
9. Connectivity Verification is completed.
