**NUMBER:** 08-070-13 REV. A

RHR RHW Or RHP Radio Navigation Map Enhancements

This bulletin involves updating the RHR,RHP or RHW radios navigation map database software.

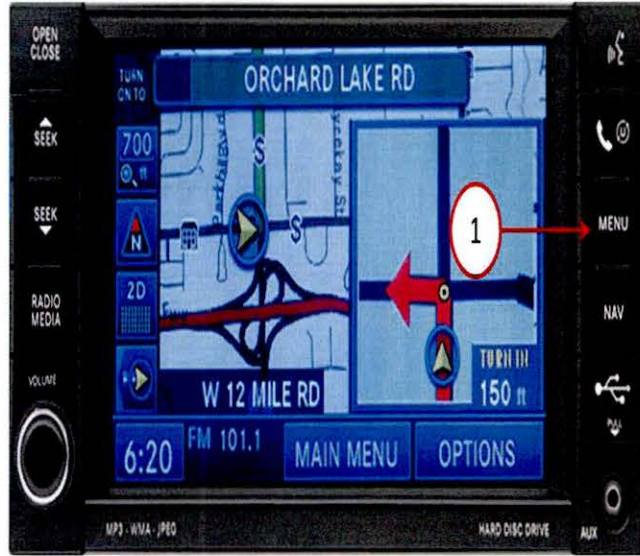
**Fig. 1 Radio Face Plate**

1 - MENU Key

1. Start the vehicle.
2. Turn the Radio on.
3. Press the MENU key (Fig. 1).

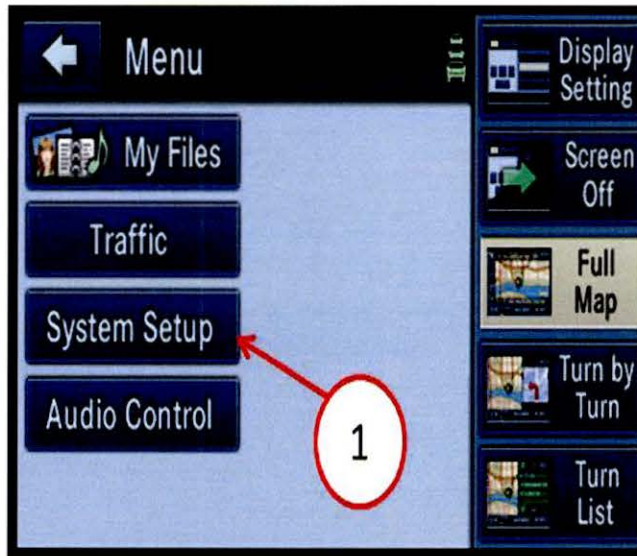
**Fig. 2 Radio Face Plate**

1 - System Setup

4. Press System Setup (Fig. 2).

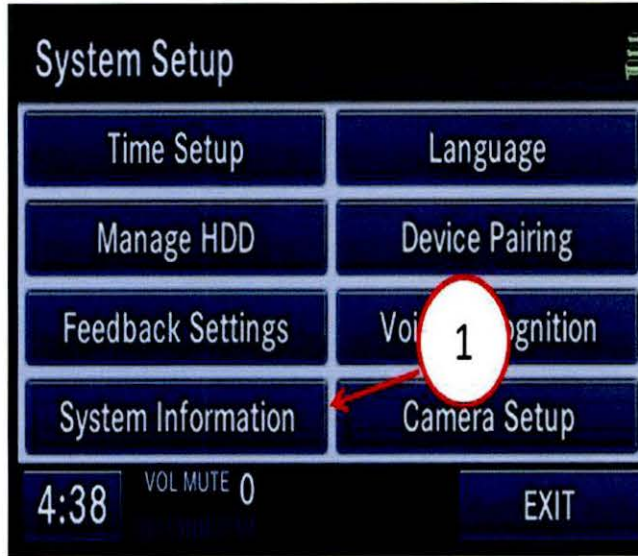
**Fig. 3 Radio Face Plate**

1 - System Information

5. Press System Information (Fig. 3).

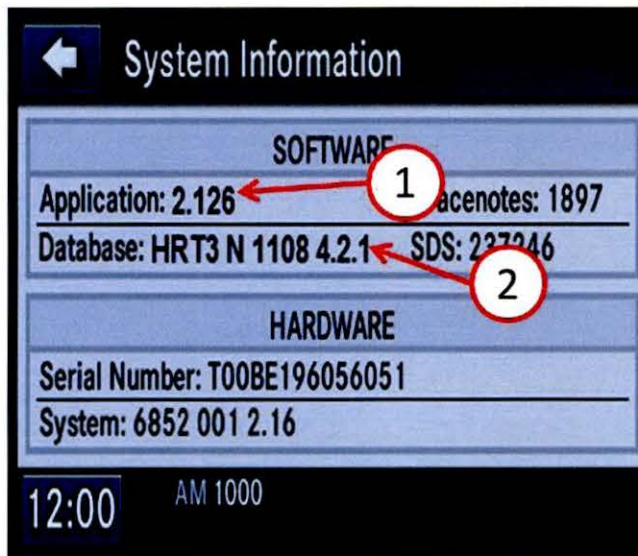
**Fig. 4 Software Versions**

1 - Application Version

2 - Database Software Version

- 
- 6. Is the application software level at 2.184? (Fig. 4).
    - a. No >>> Perform service bulletin 08-066-13 first, before proceeding with this bulletin.
    - b. Yes >>> proceed to [Step #7](#).

7. Is the database software level at 4.3.1 or higher? (Fig. 4).
  - a. Yes >>> This service bulletin doesn't pertain, normal diagnostic should be performed.
  - b. No >>> Proceed to [Step #8](#).
8. An activation key is required and must be obtained by going to <http://www.navteq.com/freshmaps/chryslerdealers>. You must have the vehicle VIN before you can obtain a functional activation key.

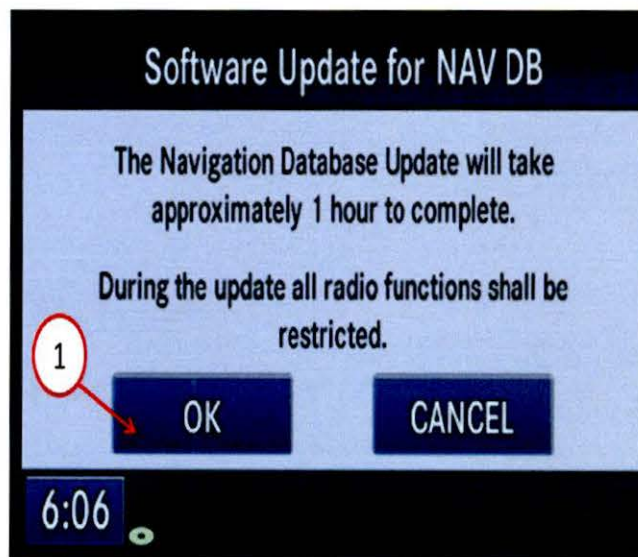
**Fig. 5 Radio Face Plate**

1 - Press OK

9. Insert the navigation map update disc into the radio by pressing OPEN/CLOSE and inserting the update disc.
10. The radio will read the contents of disc and will prompt the user to select "OK" or "CANCEL" as shown in the screen below. It may take approximately 2 minutes for this prompt to display (Fig. 5).

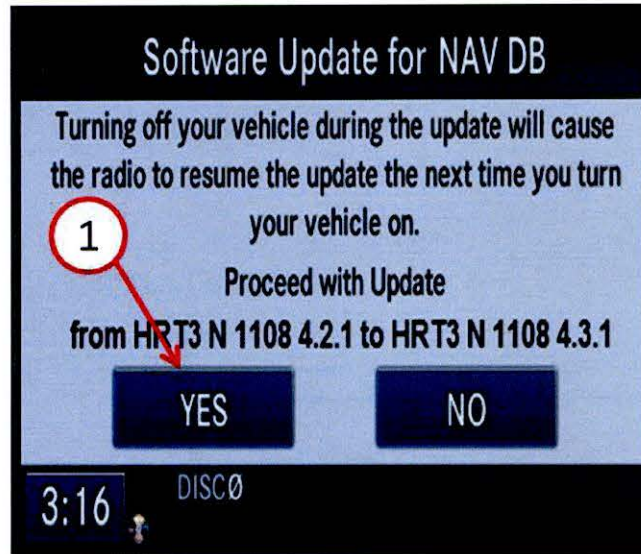
**Fig. 6 Current and Update Software Level**

1 - To Proceed Select "YES"

- 
11. Press "OK"(Fig. 5).
  12. The next screen will display the current and new version of the navigation map database software (Fig. 6).
  13. Press YES to continue.

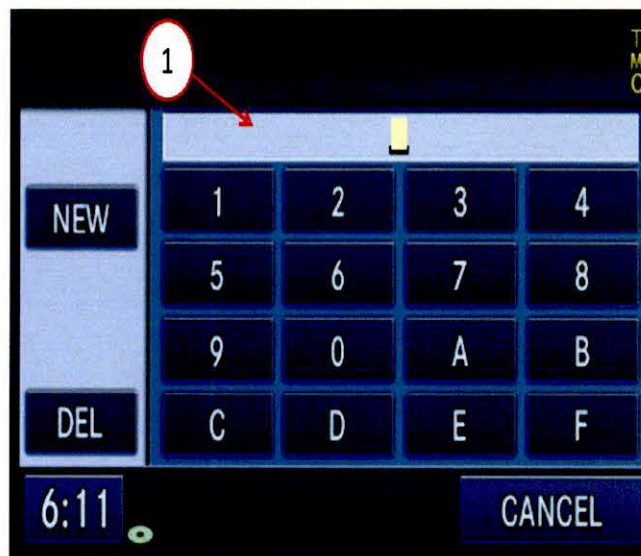
**Fig. 7 Radio Face Plate**

1 - Activation Key

14. When prompted by the radio enter the activation key obtained in [Step #8](#).

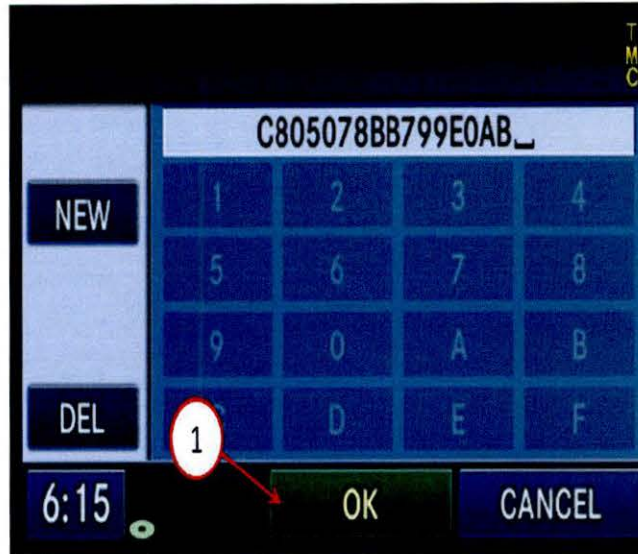
**Fig. 8 Radio Face Plate**

1 - Press OK

15. After successful entry of the activation key, the following screen will be displayed (Fig. 8).

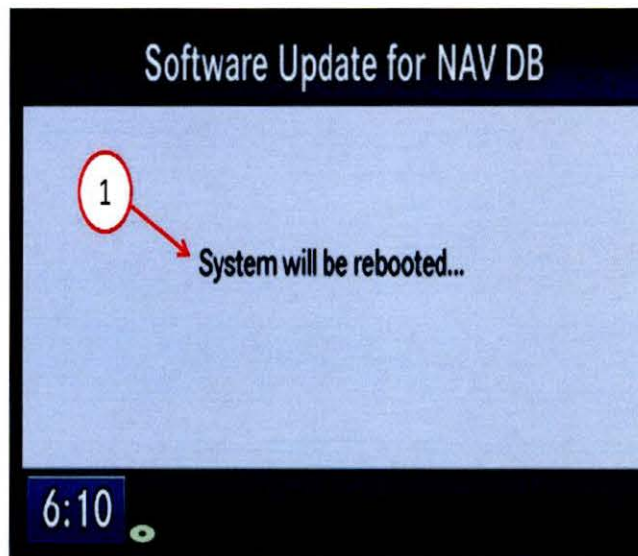
**Fig. 9 Radio Face Plate**

1 - System Reboot

- 16. Press "OK" and the update process will begin.
- 17. The following screen will be displayed (Fig. 9).

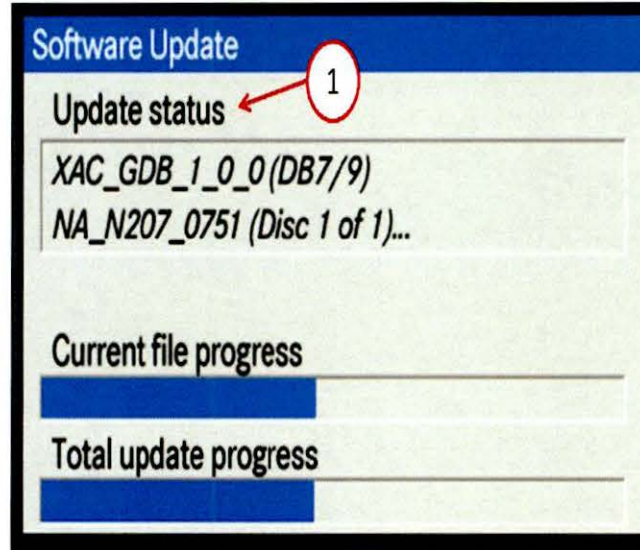
*Fig. 10 Radio Face Plate*

1 - Status

18. After the radio resets, the following screen will be displayed (Fig. 10)

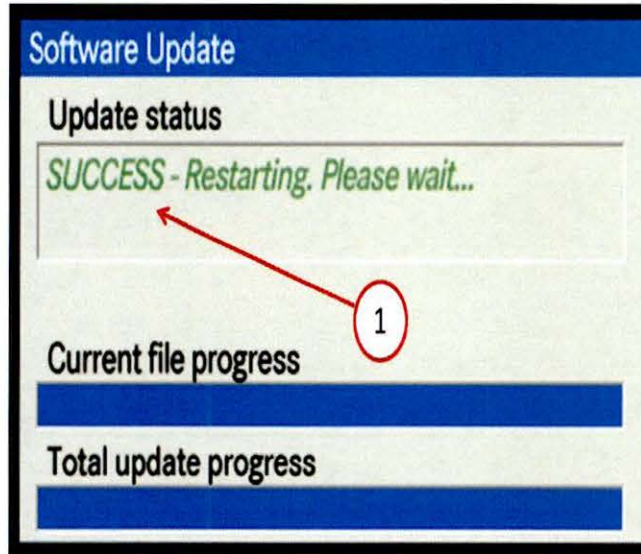
**Fig. 11 Radio Face Plate**

1 - Success

19. After successful update, the following screen will be displayed (Fig. 11)
