NUMBER: 08-070-13 REV. C

GROUP: Electrical

DATE: October 19, 2013

RHR RHW Or RHP Radio Navigation Map Enhancements

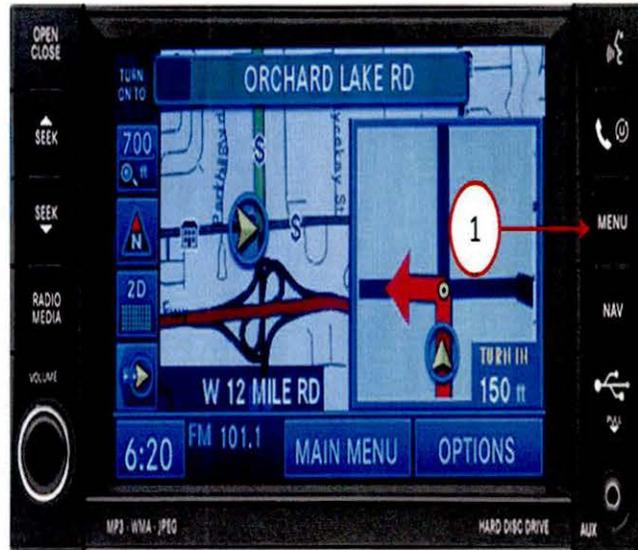
Fig. 1 Radio Face Plate

1 - MENU Key

1. Start the vehicle.
2. Turn the Radio on.
3. Press the MENU key (Fig. 1).

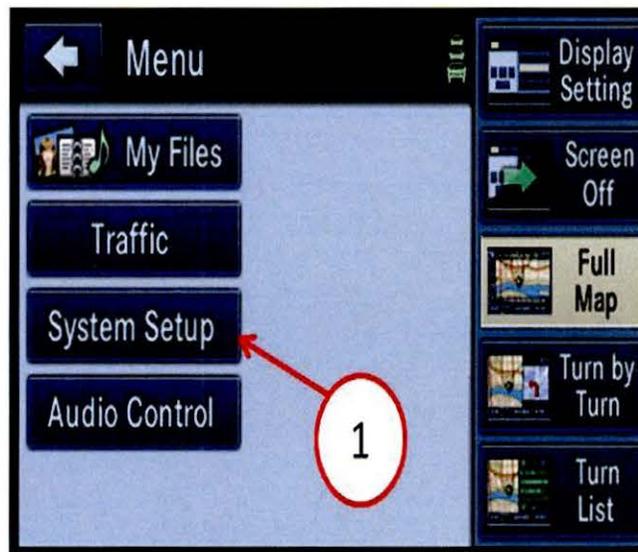
Fig. 2 Radio Face Plate

1 - System Setup

4. Press System Setup (Fig. 2).

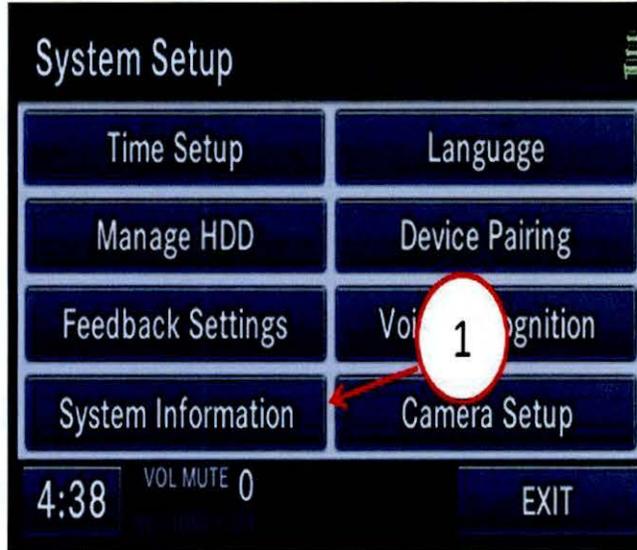
Fig. 3 Radio Face Plate

1 - System Information

5. Press System Information (Fig. 3).

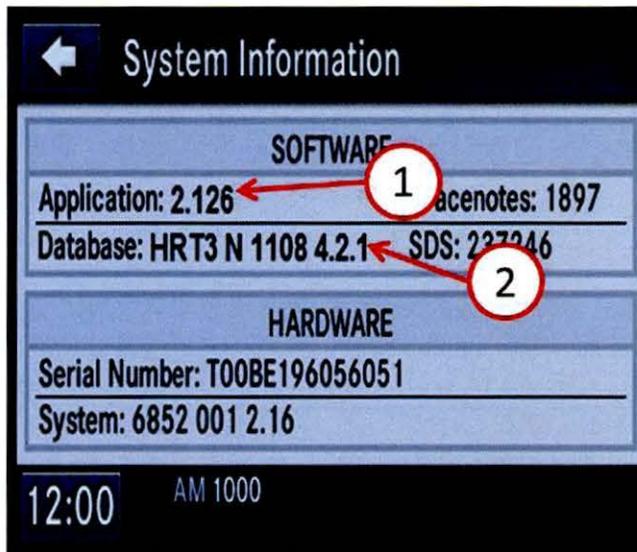
Fig. 4 Software Versions

1 - Application Version

2 - Database Software Version

-
- 6. Is the application software level at 2.184? (Fig. 4).
 - a. No >>> Perform service bulletin 08-066-13 first, before proceeding with this bulletin.
 - b. Yes >>> proceed to [Step #7](#).

7. Is the database software level at 4.3.1 or higher? (Fig. 4).
 - a. Yes >>> This service bulletin doesn't pertain, normal diagnostic should be performed.
 - b. No >>> Proceed to [Step #8](#).
8. An activation key is required and must be obtained by going to <http://www.navteq.com/freshmaps/chryslerdealers>. You must have the vehicle VIN before you can obtain a functional activation key.

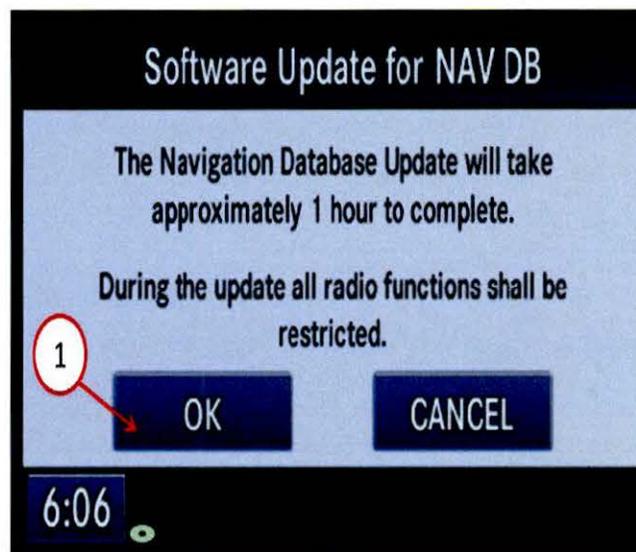
Fig. 5 Radio Face Plate

1 - Press OK

9. Insert the navigation map update disc into the radio by pressing OPEN/CLOSE and inserting the update disc.
10. The radio will read the contents of disc and will prompt the user to select "OK" or "CANCEL" as shown in the screen below. It may take approximately 2 minutes for this prompt to display (Fig. 5).

-
11. Press "OK"(Fig. 5).
 12. The next screen will display the current and new version of the navigation map database software (Fig. 6).
 13. Press YES to continue.

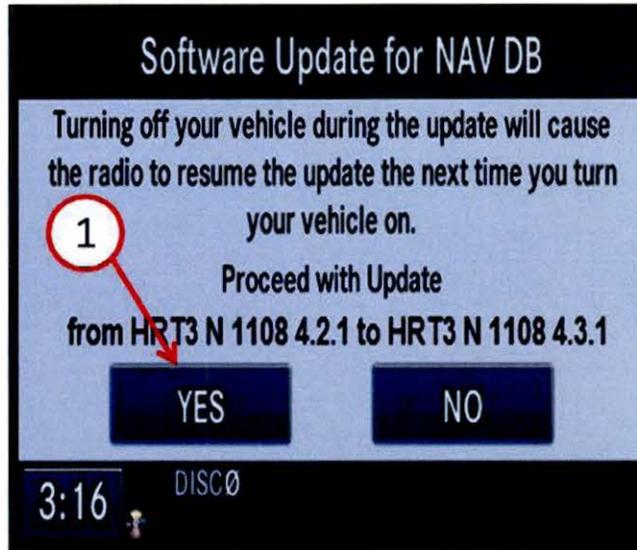
Fig. 6 Current and Update Software Level

1 - To Proceed Select "YES"

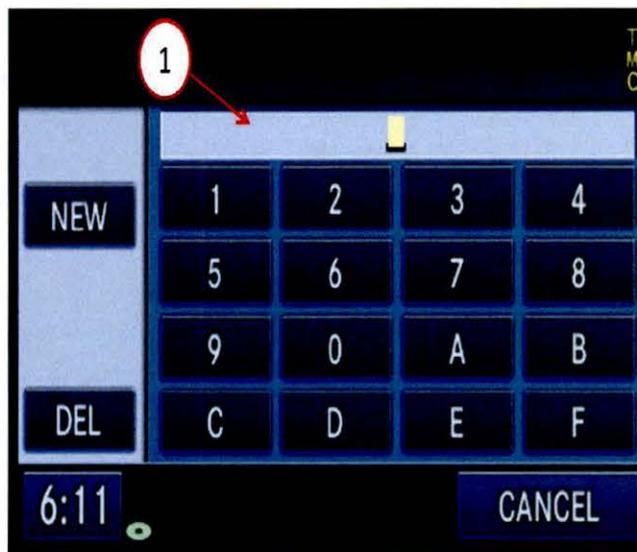
Fig. 7 Radio Face Plate

1 - Activation Key

14. When prompted by the radio enter the activation key obtained in [Step #8](#).

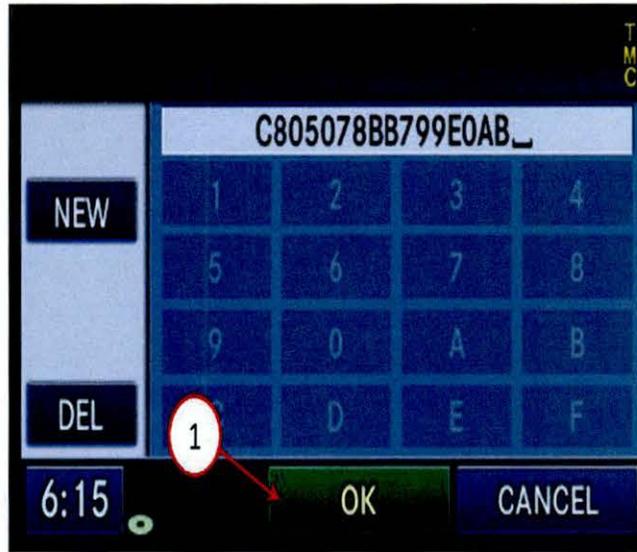
Fig. 8 Radio Face Plate

1 - Press OK

15. After successful entry of the activation key, the following screen will be displayed ([Fig. 8](#)).

- 16. Press "OK" and the update process will begin.
- 17. The following screen will be displayed (Fig. 9).

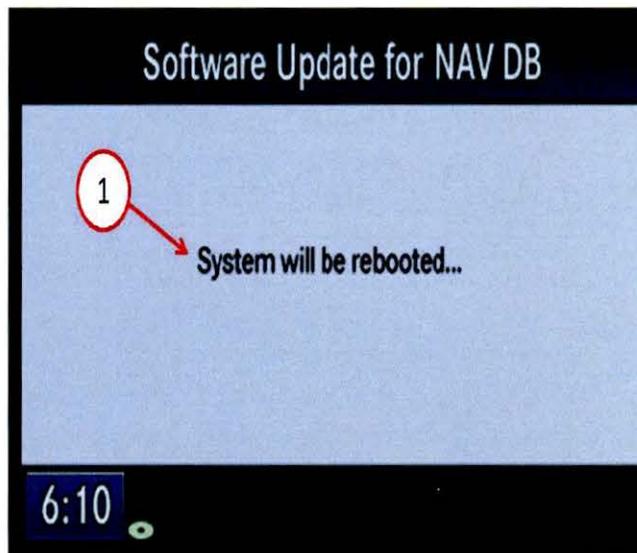
Fig. 9 Radio Face Plate

1 - System Reboot

NOTE: The update may take up to 1 hour to be completed. Once the update has been started no other action is needed from the technician. The tech can perform other duties while the navigation system is being updated.

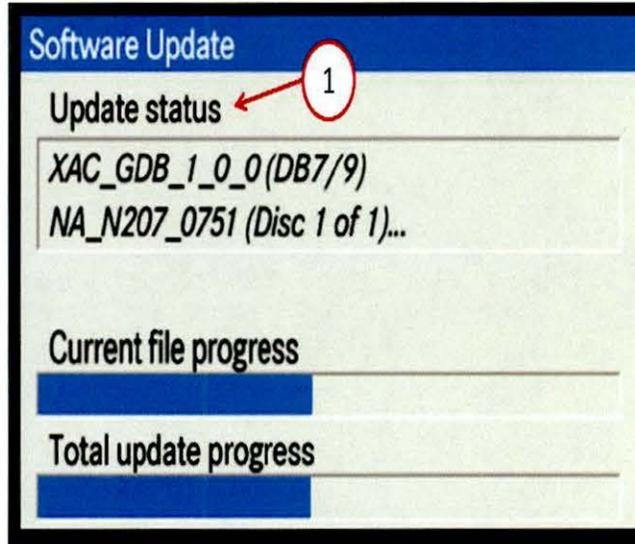
Fig. 10 Radio Face Plate

1 - Status

18. After the radio resets, the following screen will be displayed (Fig. 10)

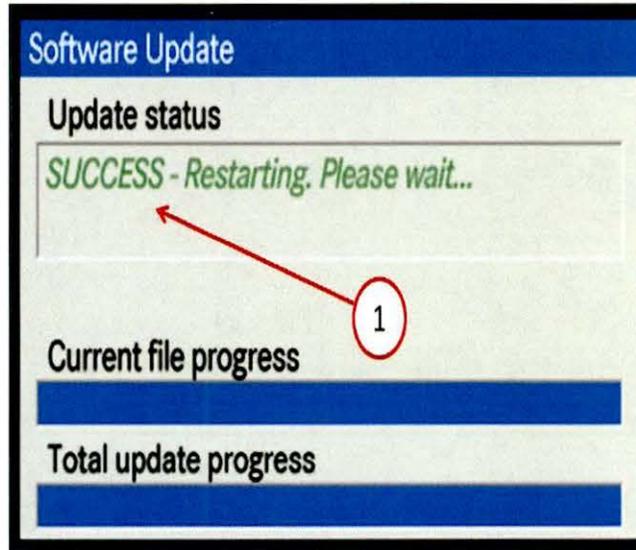
Fig. 11 Radio Face Plate

1 - Success

19. After successful update, the following screen will be displayed (Fig. 11)
