NUMBER: 08-075-13

Radio Locks Up Intermittently On Rough Roads

This bulletin involves removing a burr from the integrated center stack bezel.

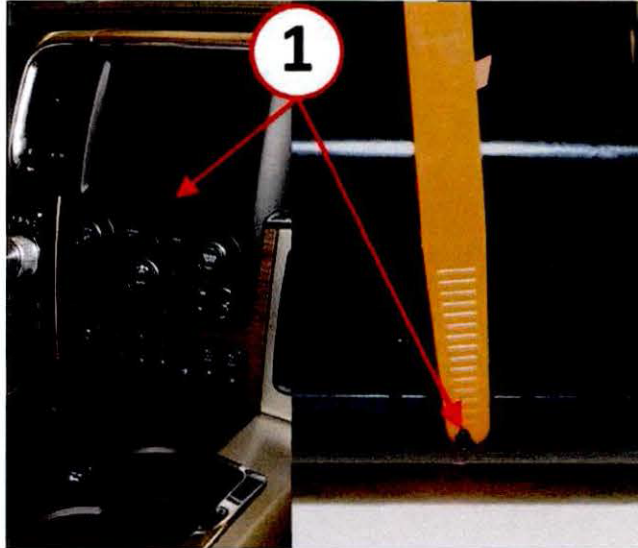
Fig. 1 Injection Molding Bump Location

1. Remove the instrument panel center bezel. Refer to the detailed repair procedures available in: DealerCONNECT> TechCONNECT under: Service Info> 23 - Body> Instrument Panel> BEZEL, Instrument Panel, Center> Removal.
2. In location shown, inspect for a plastic injection molding flash bump on the backside of the integrated center stack bezel which may contact the touch screen when installed (Fig. 1).

1 - Plastic Injection Molding Flash Bump

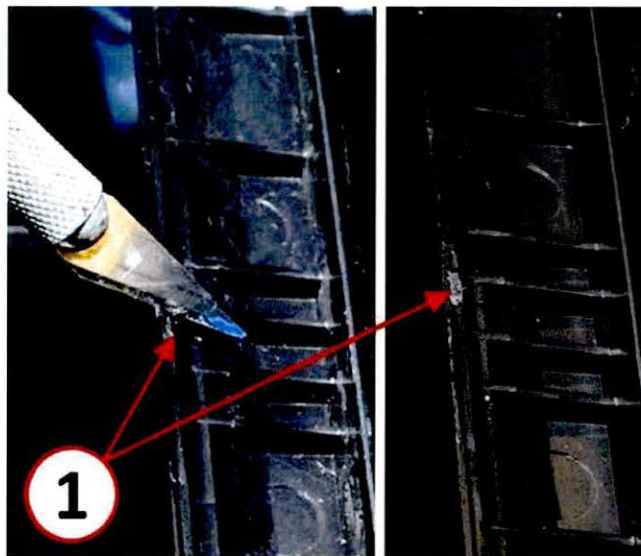
Fig. 2 Injection Molding Bump Removal

1 - Plastic Injection Molding Flash Bump

3. Using an appropriate tool, remove the injection molding flash bump on the backside of the integrated center stack bezel to insure a flush surface (Fig. 2).
