NUMBER: 08-075-13

Radio Locks Up Intermittently On Rough Roads

This bulletin involves removing a burr from the integrated center stack bezel.

2013 - 2014	(DS)	1500 Pickup
2013 - 2014	(DJ)	2500 Pickup
2013 - 2014	(D2)	3500 Pickup
2013 - 2014	(DD)	3500 Cab Chassis
2013 - 2014	(DP)	4500/5500 Cab Chassis
2013 - 2014	(DX)	Truck (Mexico)

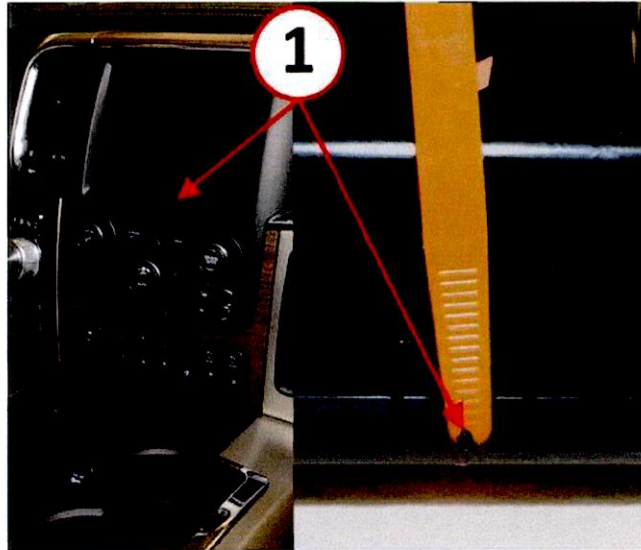
A customer may experience the radio and touchscreen will lock up intermittently, most often while driving on rough roads. No DTC's will be found.

1. Remove the instrument panel center bezel. Refer to the detailed repair procedures available in: DealerCONNECT> TechCONNECT under: Service Info> 23 - Body> Instrument Panel> BEZEL, Instrument Panel, Center> Removal.
2. In location shown, inspect for a plastic injection molding flash bump on the backside of the integrated center stack bezel which may contact the touch screen when installed (Fig. 1).

Fig. 1 Injection Molding Bump Location

1 - Plastic Injection Molding Flash Bump

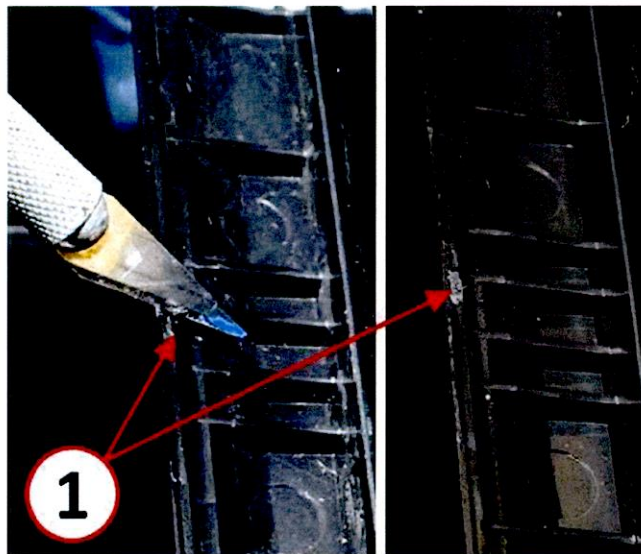
Fig. 2 Injection Molding Bump Removal

1 - Plastic Injection Molding Flash Bump

3. Using an appropriate tool, remove the injection molding flash bump on the backside of the integrated center stack bezel to insure a flush surface (Fig. 2).
